FRANK C. HAVENS ELEMENTARY SCHOOL
PIEDMONT UNIFIED SCHOOL DISTRICT
Seismic Strengthening Program / Measure E Bond Program

COMBINED INVESTIGATION & CONCEPT DESIGN REPORTS
FINAL REPORT

March 18, 2008

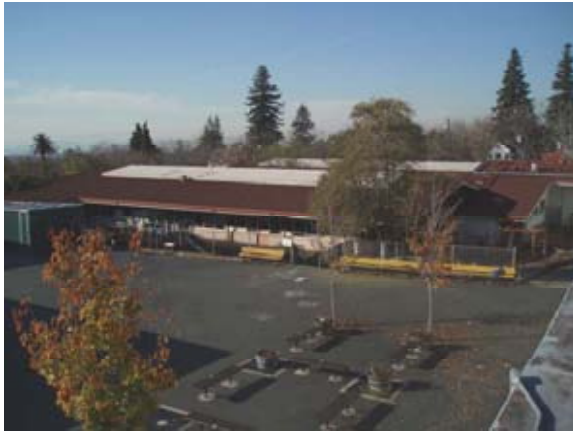
installed on Lines 7 and 8, and the deficient roof diaphragm chords strengthened by adding steel straps. It would also be desirable to add vertical bracing elements along the north and south walls of the classroom wings to limit damage to those walls and maintain possible egress through them. There are also many lesser, yet still important elements that will require strengthening. These and alternate schemes would be defined in upgrade studies.

Figure 1 – South classroom wing of Building A.

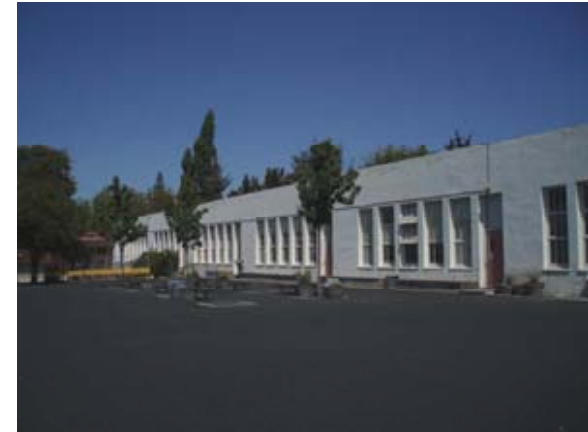
Figure 4 - West side of Building B. Note the many windows and doors.

To fix the major deficiencies found, much stronger shear walls will need to be installed on the east and west (long) sides of the building. This can probably be done by rebuilding the existing walls with double sided plywood, strong hold-downs, and possibly new foundations. Also, the roof chords can be strengthened with steel straps. The missing information of Connections A, B and C must be established and/or these important connections strengthened. There are also a number of lesser yet important other components that will have to be strengthened. These and alternative schemes would be defined in upgrade studies.

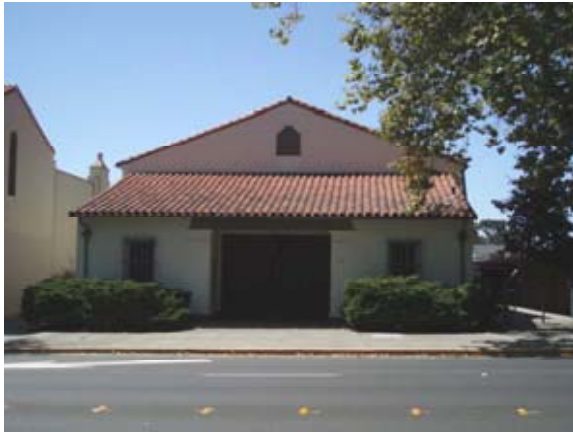
Figure 7 - Front of Building C. The building has a heavy tile roof.

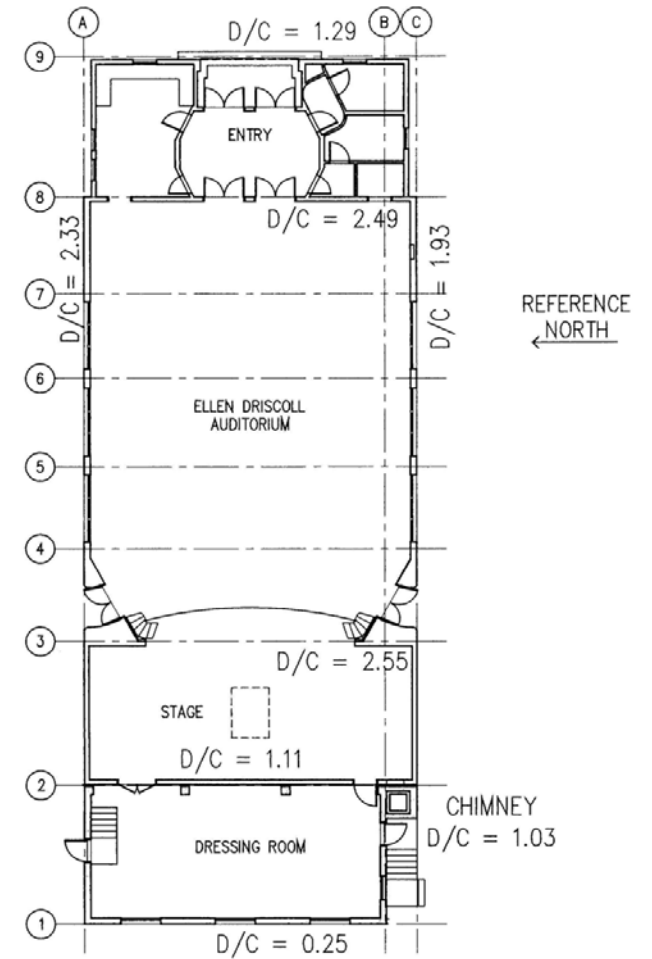
Figure 9 - Floor plan of Building C. Demand to capacity (D/C) ratios for the principal shear walls are also indicated.
