**MAINTENANCE BUILDINGS**  
**PIEDMONT UNIFIED SCHOOL DISTRICT**  
**SEISMIC STRENGTHENING PROGRAM / MEASURE E BOND PROGRAM**

**INVESTIGATION AND ANALYSIS**  
**FINAL REPORT**

# MAINTENANCE BUILDINGS

# INVESTIGATION AND ANALYSIS

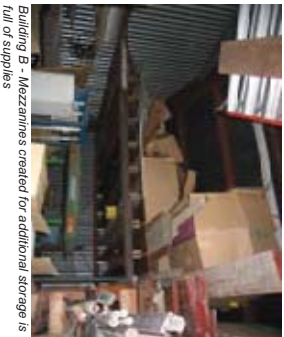
Building B - Mezzanines created for additional storage is full of supplies

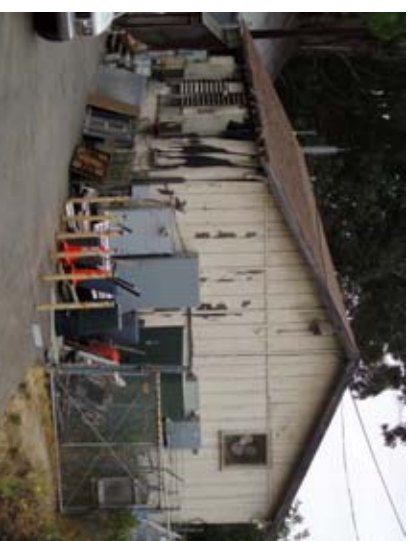
No drawings for the building are available, and a survey by a structural engineer from our office was conducted. The general condition of the exterior of the building is poor. The paint is badly weathered, and there is rot on a number of rafter ends. Many of the exterior walls have had large openings made for windows. Some have subsequently been covered over.

Figure 2 – Wood frame building. This is showing deterioration on its the exterior. The ends of many roof rafters are rotten and the paint is peeling off the siding in many places.

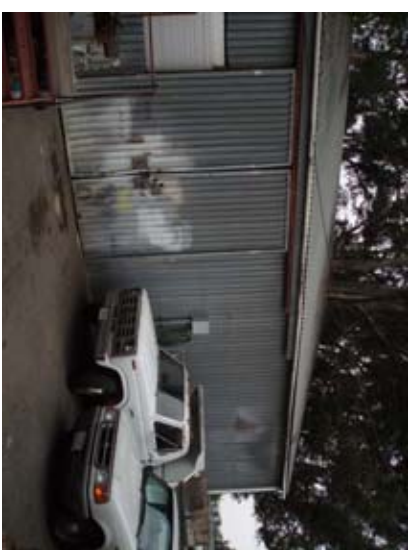
The building was evaluated and found not meet the Tier 1 criteria. There are several noncompliant items. These include nonconforming moment-connections in the moment frames and the missing roof bracing. The vertical rod X-bracing in the walls does not meet criteria. It has a demand to ratio capacity (D/C) of 1.2.

Figure 5 – Prefab metal building. This structure was relocated to the site from another location and is in relatively good condition for its age.

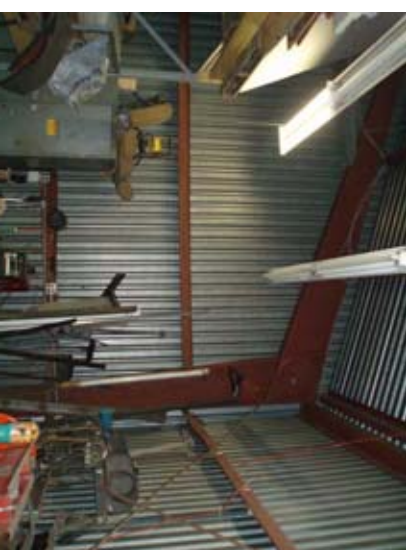
Figure 6– Inside view of the prefab metal building showing a moment frame and rod bracing.

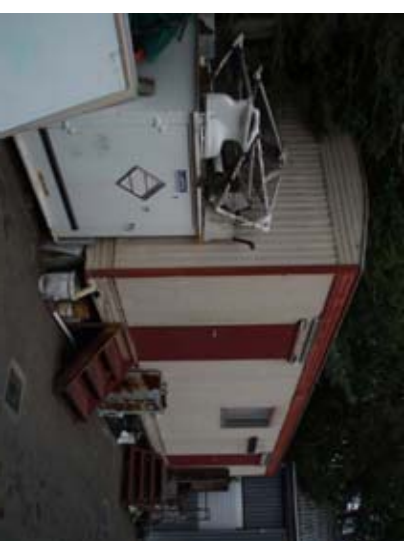
The large trailer (Figure 7) is 10' x 32' in plan. It consists of two "rooms", an office and a restroom. Its floor level is about 2 feet above the ground. It is vertically supported on several small, slender individual precast concrete footings. These are about 18 inches tall and provide only vertical support. The trailer lacks foundation anchorage.

The large trailer does not meet the Tier 1 criteria because it lacks foundation anchorage. Trailers and mobile homes without anchorage frequently fall off their supports in earthquakes (see Figure 8). While the life safety risk is generally small, immediate use of the trailer afterwards is prevented and repairs are generally required.

Figure 7 – Large trailer.

Both trailers are very vulnerable to falling off their supports in an earthquake. This deficiency can be fixed by installing bracing to secure the trailer to the ground. Because of their age (estimated to be more than 25 years), the devices manufactured today may not be adaptable to them, but it is possible to build custom hardware to secure them. The California Department of Housing and Community Development maintains standards for seismic bracing of mobile homes, and these can be used as a design basis.

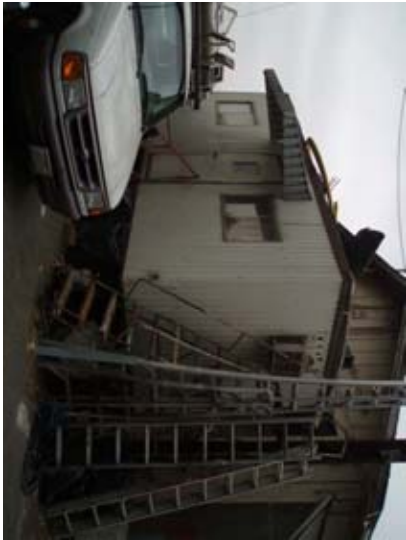
The small trailer (Figure 9) is 8' x 20' in plan. It is vertically supported by several steel jacks (Figure 10). Similar to the large trailer, it does not have foundation anchorage and is vulnerable to falling off its support in an earthquake. It also does not meet the Tier 1 criteria.

Figure 9 – Small trailer.

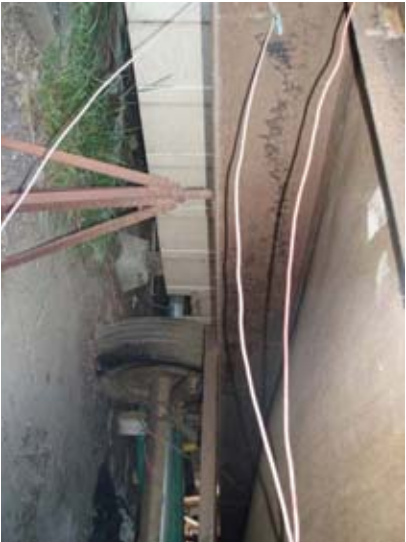
Figure 10 - Typical steel jack support for the small trailer. This type of support does not provide lateral resistance and frequently fails in earthquakes.

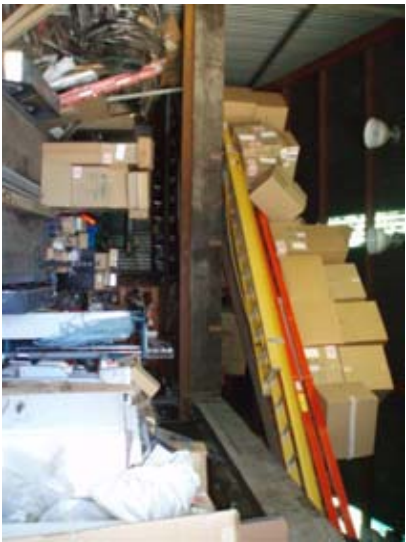
Figure 11 – Boxes are stored on a ladder placed horizontally. These constitute a falling hazard, and the storage arrangement does not meet ASCE 31 requirements.

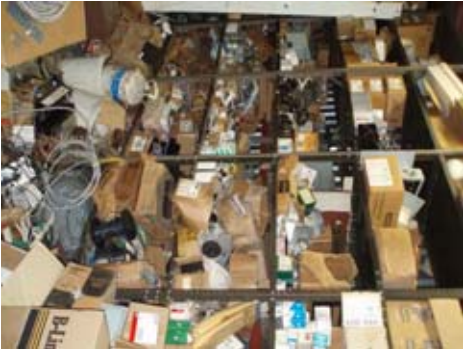
All racks, shelving and tall cabinets appear to be unanchored (the bases of many of these can not be seen because of the clutter). Those over 4 feet tall with height to depth ratios of 3.0 or greater are considered a hazard to overturn (Reis, 1 and 2).

Figure 12 – The contents of these metal storage shelves can topple. Additionally, some shelves in the building are not anchored to the floor and can slide or tip over.

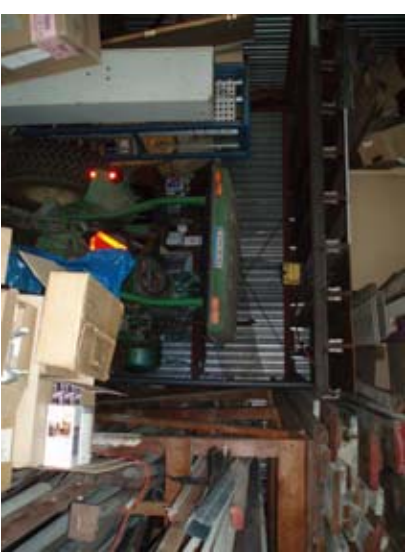
Materials stored on the mezzanines are unrestrained and can fall off during an earthquake, creating a falling hazard.

Figure 13 – An ad hoc mezzanine was installed in S/E corner of the prefab building. Materials on it are unrestrained and can fall off.

(4) The two mezzanines within the prefab building need to be either removed or replaced with code-compliant structures.

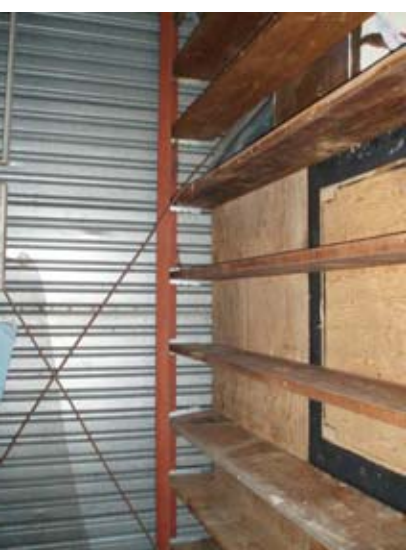
Figure 14 – One end of the joists supporting the S/E mezzanine are vertically supported by a light-gauge girtd. Girds are designed to resist horizontal wind loads and not substantial vertical dead loads. This arrangement does not meet building code structural requirements.

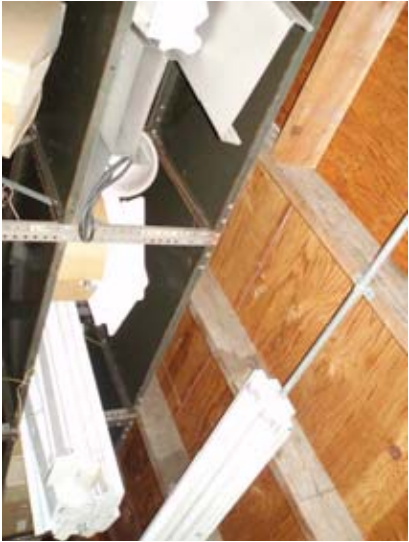
Figure 15 – The west mezzanine is partially supported on the tops of steel shelving.

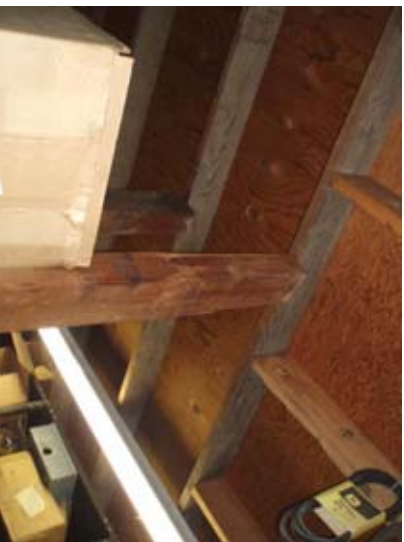
Figure 16 – Wood posts supporting the west mezzanine are not structurally connected at their tops. This arrangement does not meet code structural requirements.
