PIEDMONT HIGH SCHOOL

PIEDMONT UNIFIED SCHOOL DISTRICT

Seismic Strengthening Program / Measure E Bond Program

COMBINED INVESTIGATION & CONCEPT DESIGN FINAL REPORTS FOR FOUR NON-PRIORITY BUILDINGS

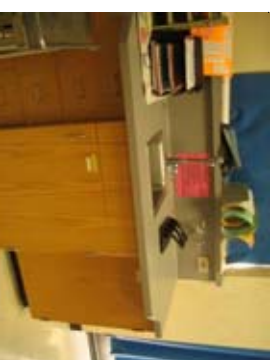
Building E - Laboratory sinks are non-accessible.

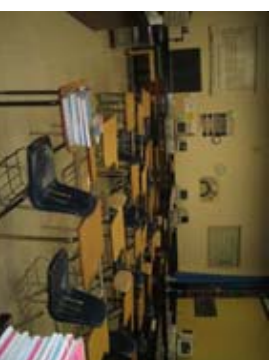
Building E - Laboratory tables are non-accessible throughout.

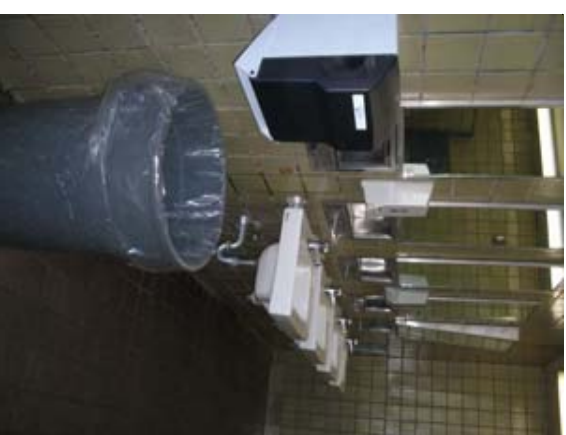
Building E - Student bathrooms are not accessible.

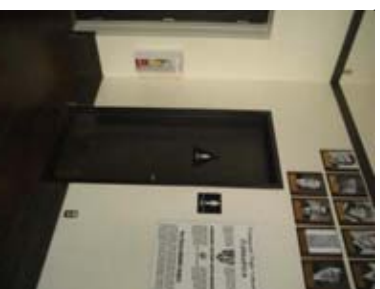
Building F - Toilet room / Lobby addition lacks proper accessibility signage.

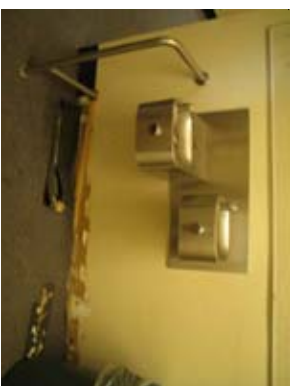
Building G - Water fountain at upper floor lacks one handrail.

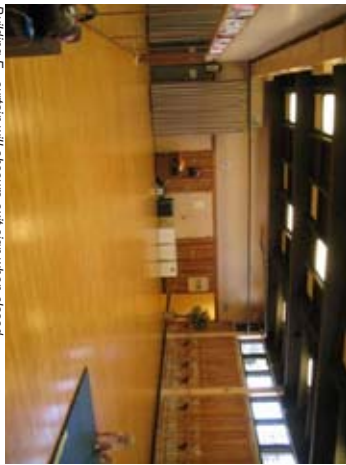
Building F - curtain will obscure exit sign when closed.

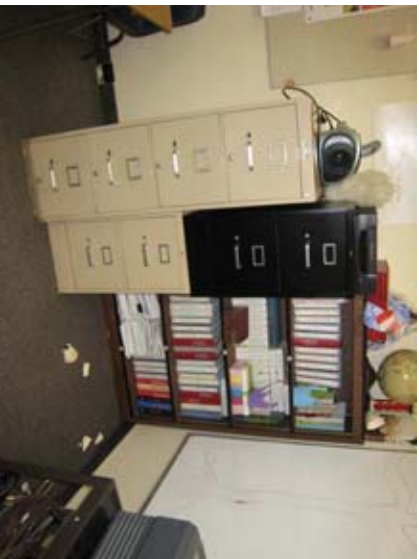
Figure 5 – The bookcase at right is unanchored, and placement of one file cabinet on top of another creates an additional falling hazard.

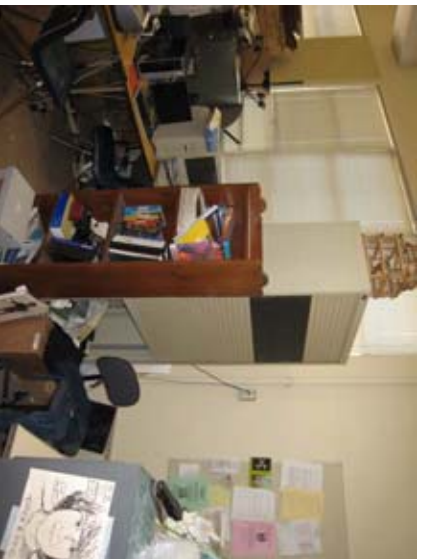
Figure 6 – Unanchored tall metal storage cabinet in Building G. Bookcase next to the cabinet is also unanchored.

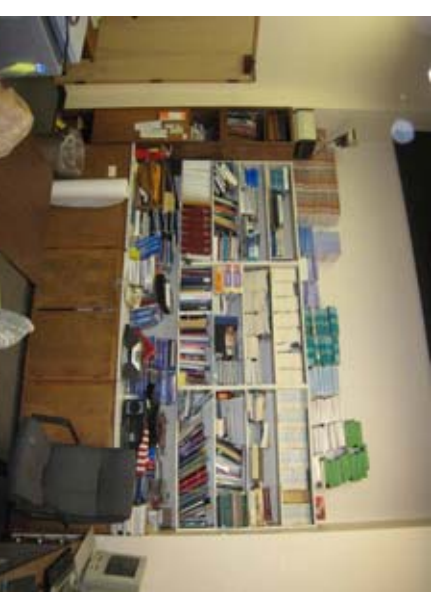
Figure 7 – Stored materials in the Social Science Resource Center in Building D.

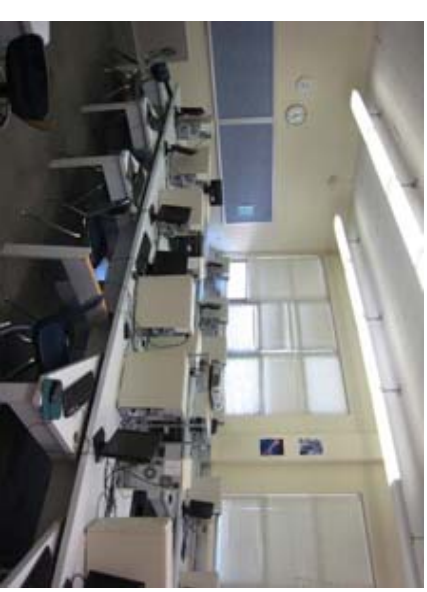
Figure 8 – Unanchored computers in a computer lab in Building G.

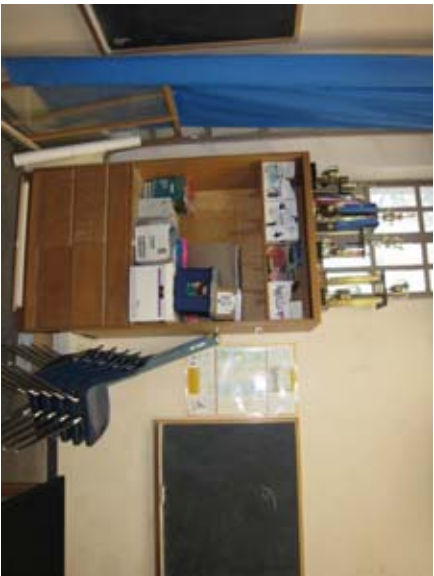
Figure 9 – Both the trophies stored on the top of this bookcase and the unanchored bookcase are falling hazards. The trophies are sufficiently heavy that they could cause a head injury.

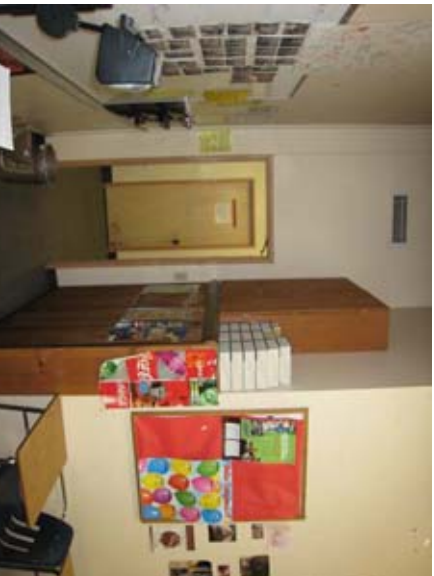
Figure 10 – The top cabinet at right is anchored to the wall, but its contents can fall out if the latch is not engaged. This would interfere with a safe exit of students from the room.

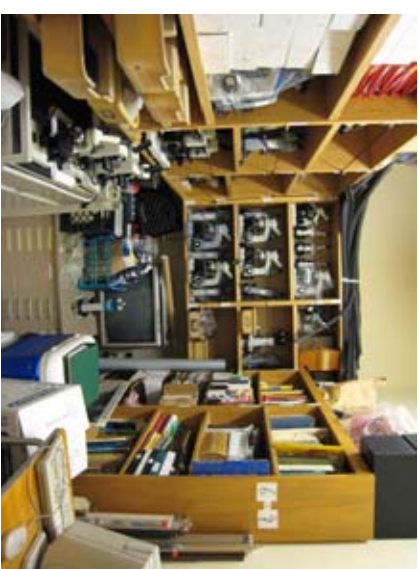
Figure 11 – Microscopes in this room in Building E are restrained on shelves by chords placed across the front.

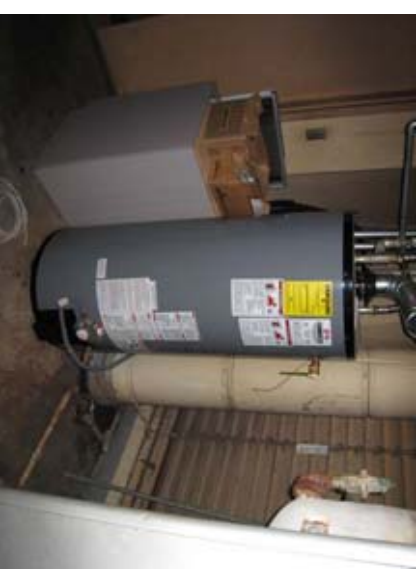
Figure 12 – Unbraced water heater in building G. This can fall over and break its gas line.

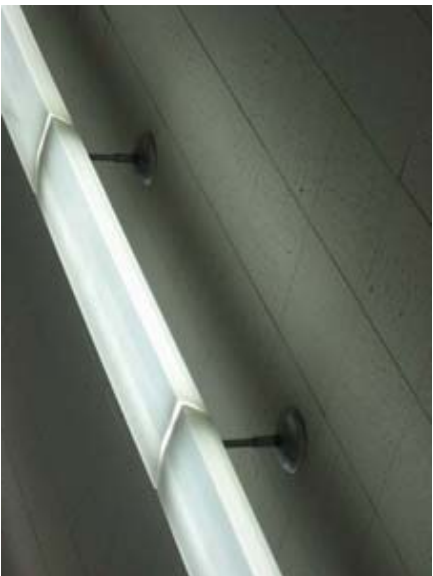
Figure 13 – Pendant-type fluorescent light fixture used in Building G.

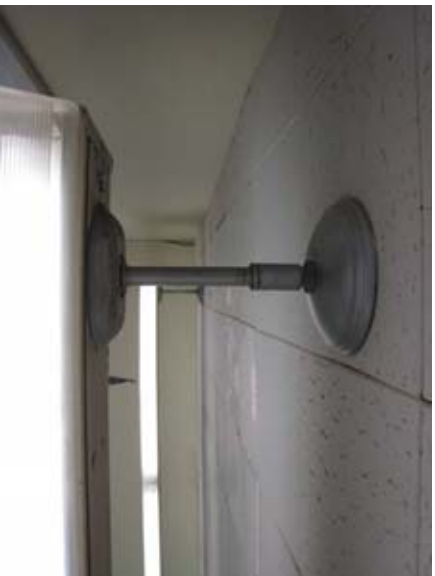
Figure 14 – Typical top and bottom supports for pendant fixtures shown in Figure 13.

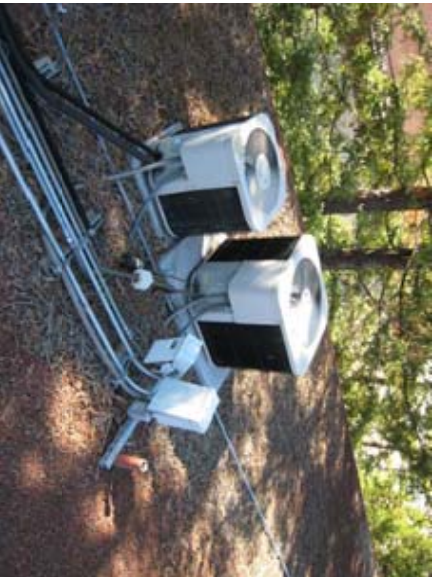
Figure 17 – Unanchored A/C units on the roof of Building G.

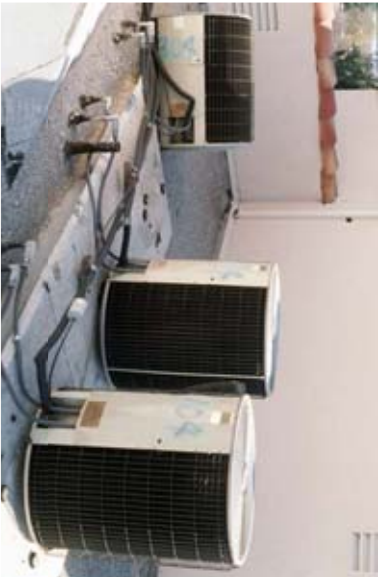
Figure 18 – Overturned A/C unit on the roof of a Northridge, California apartment building following the 1994 earthquake.

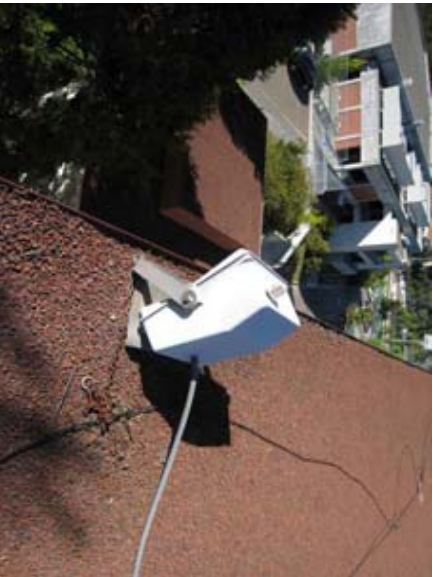
Figure 19 – This floodlight on the edge of the Building G roof is one of three that are not anchored. These can fall off.

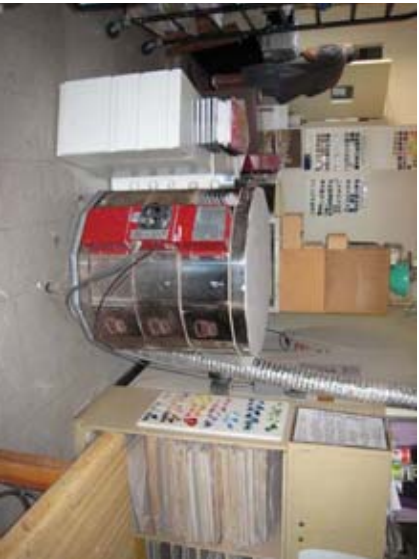
Figure 20 – One of two unanchored kilns in the Building G ceramics room.
