**PIEDMONT HIGH SCHOOL
PIEDMONT UNIFIED SCHOOL DISTRICT
SEISMIC STRENGTHENING PROGRAM / MEASURE E BOND PROGRAM**

**INVESTIGATION AND ANALYSIS,
AND CONCEPT DESIGN
FINAL REPORT
FOR THREE PRIORITY BUILDINGS**

March 6, 2008

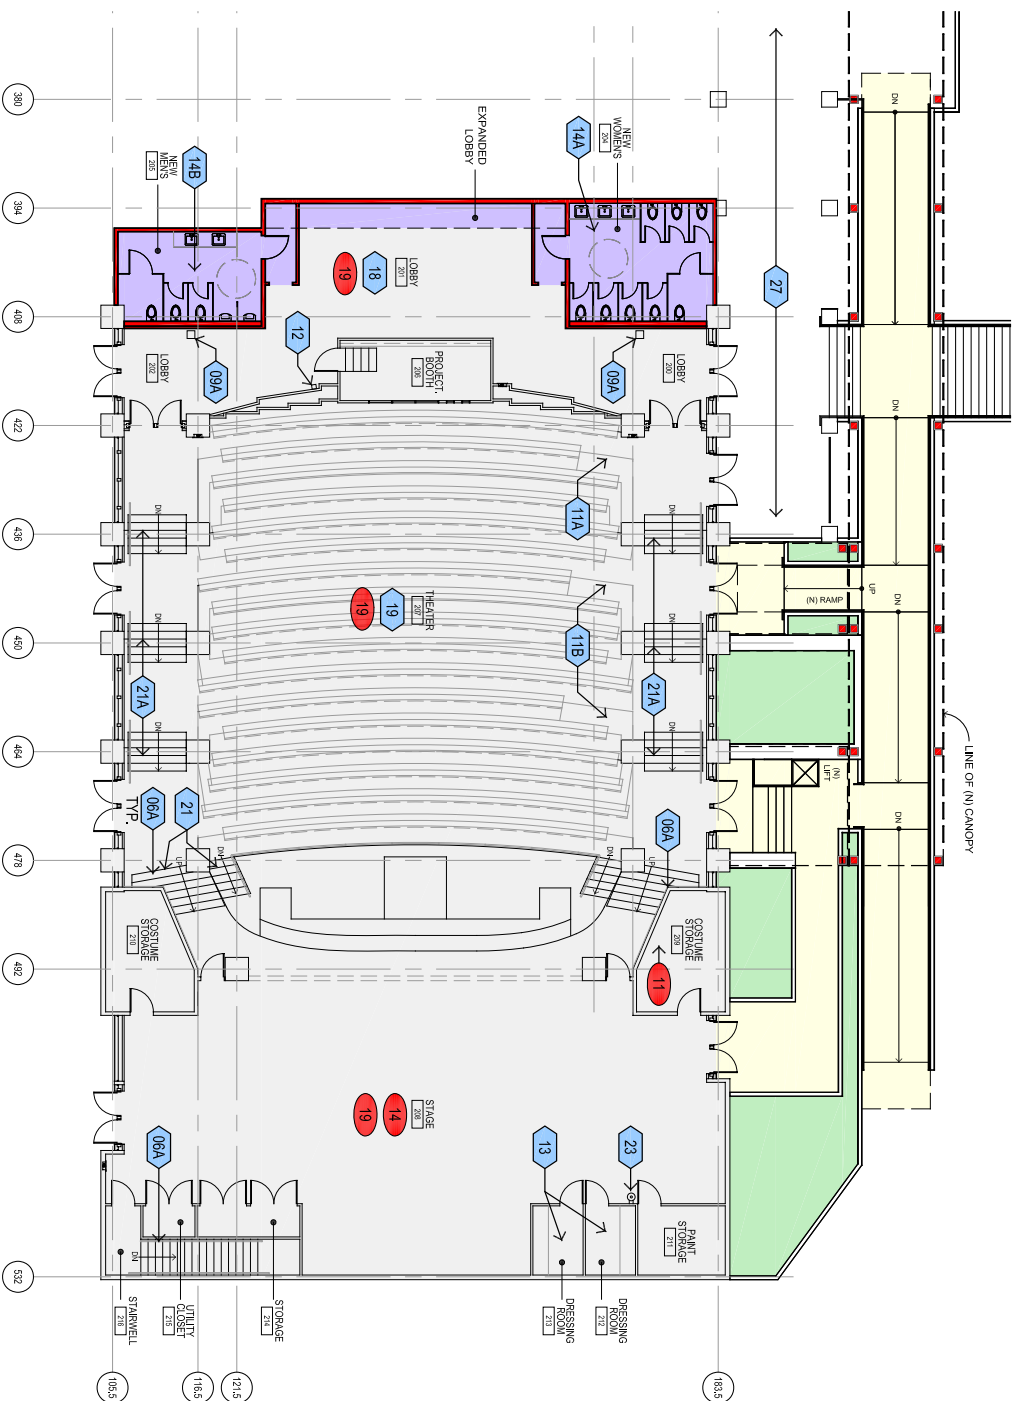
BUILDING C - MAIN LEVEL - ALLEN HARVEY THEATER - OPTION NO. 1

DSA REQUIRES 6 DISPERSED SEATS IN THE THEATER. THE CURRENT THEATER HAS 2 IN THE REAR ONLY

CONCEPT DESIGN OPTION NO. 1 PROVIDES NEW RAMP & WHEEL CHAIR LIFT WITH COVERED WALKWAY ALONG THE ENTIRE PATH OF TRAVEL FROM LOBBY TO THE ACCESSIBLE SEATING

BASED ON PAST EXPERIENCE, THIS MAY BE THE MINIMUM MITIGATION MEASURES DSA WILL ACCEPT

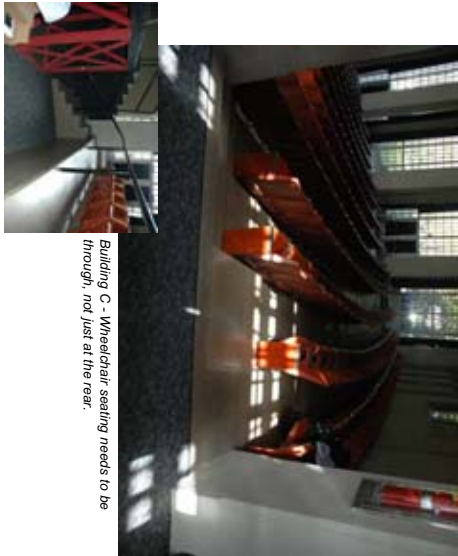
Building C - Wheelchair seating needs to be through, not just at the rear.

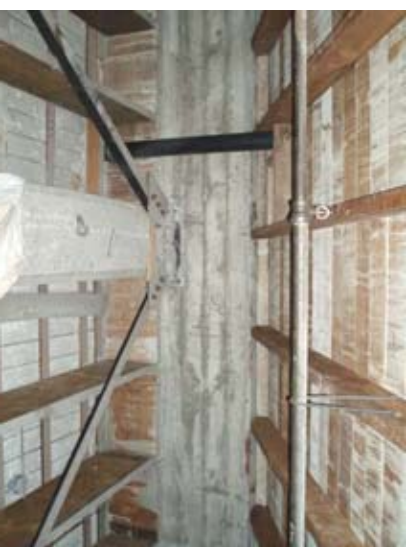
Figure 5 – View of Quad building attic showing some of the horizontal steel bracing used in the attic level diaphragms.

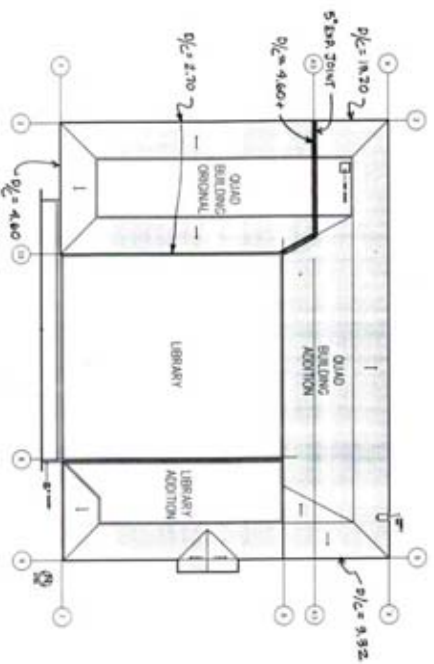
Figure 6 – Roof plan of the Quad building showing demand to capacity ratios (D/C) for the roof diaphragms.

The existing roof sheathing is replaced with new plywood sheathing. The wall-roof connections are strengthened with new steel brackets, and the truss seats are rebuilt to connect the trusses more strongly to the walls.

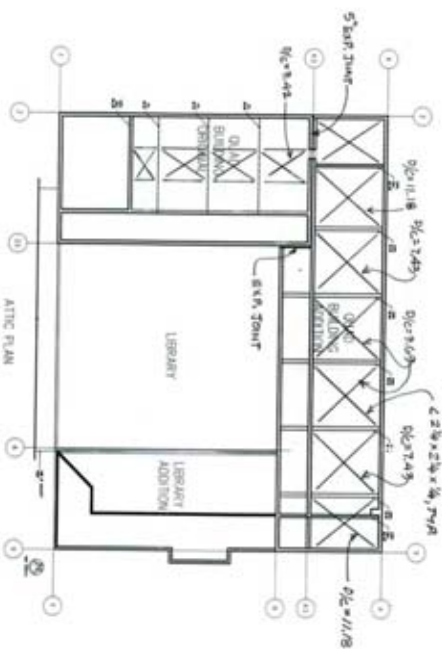
Figure 7 – Attic plan of Quad building showing demand to capacity ratios (D/C) for attic diaphragm tension bracing.

The recommended strengthening scheme is as follows. The existing roof diaphragm of straight sheathing is removed and replaced with new plywood sheathing. The attic level diaphragm, consisting of weak horizontal x-bracing, is replaced with a new, stronger horizontal steel bracing system. Two new concrete shear walls are added, one in each wing. These extend from foundations to the roof.

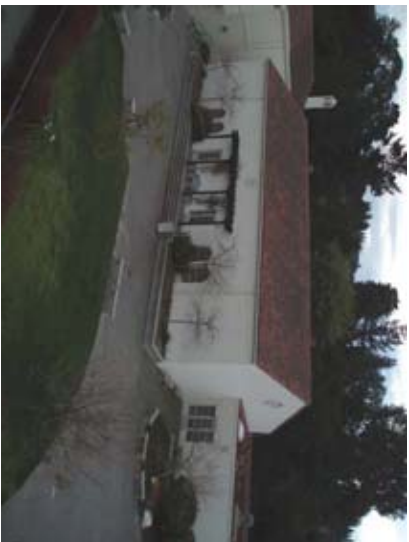
Figure 8 – View of the Student Center building. The high roof portion was originally the school library. The low roof portion on the right houses the Special Education Offices.

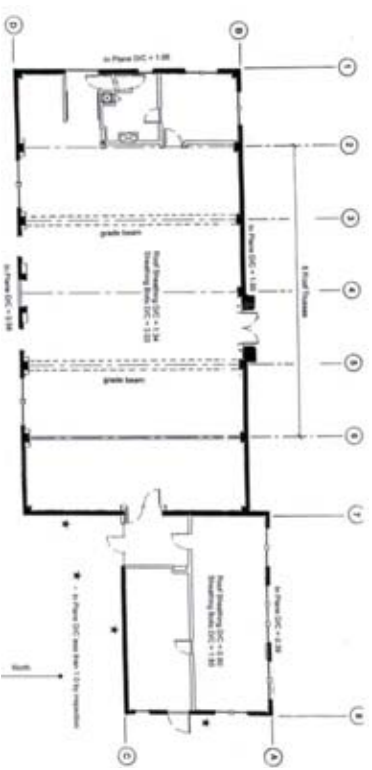
Figure 10 – Floor plan of the Student Center. Demand to capacity ratios (D/C) for the principal shear walls are also indicated.

The overstressed high roof diaphragm can be fixed by adding plywood sheathing over the existing 1 x 6 diagonal sheathing. Improvement of the wall-roof connections will require installation of new, stronger anchors or reinforcement of the existing connections. An alternative procedure for the high roof area would be to add horizontal steel bracing in the plane of the bottom chords of the roof trusses. Such bracing could prevent overstress in the high roof diaphragm and strengthen the wall-roof anchorage at the same time.

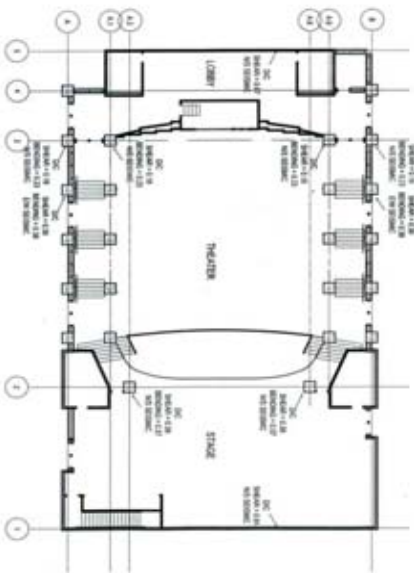
Figure 13 – Floor plan of the Alan Harvey Theater. Demand to capacity ratios (D/C) for the shear walls and concrete columns are also indicated.

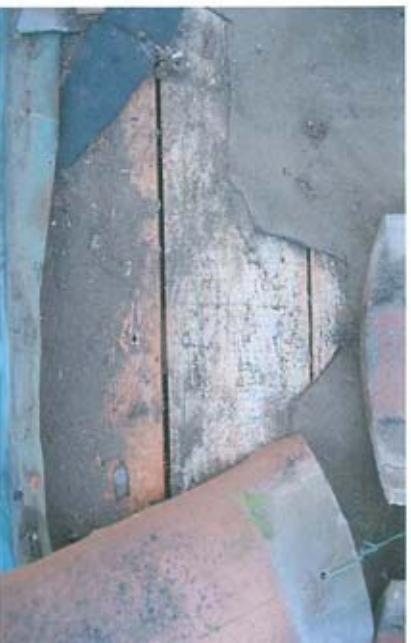
Photo 2: Close-up showing nailing of 1 x 6 roof sheathing, note: two nails each board into rafter.

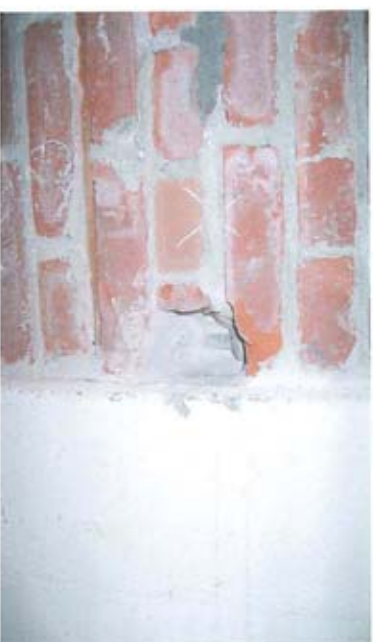
Photo 3: Exposure of horizontal bar at brick in-fill.
