# **PIEDMONT MIDDLE SCHOOL**

**PIEDMONT UNIFIED SCHOOL DISTRICT**

**Seismic Strengthening Program / Measure E Bond Program**

## **COMBINED INVESTIGATION & CONCEPT DESIGN FINAL REPORT**

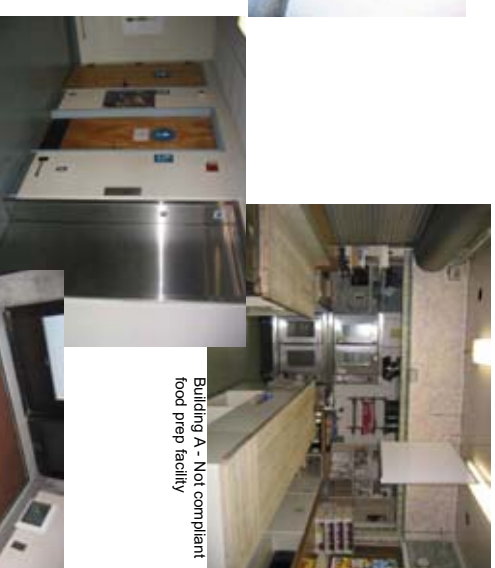
Building A - Not compliant food prep facility

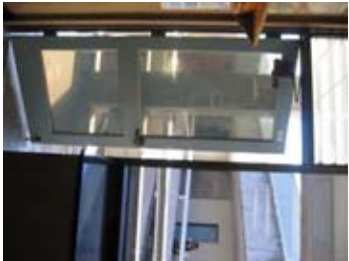
Building A - Not compliant door

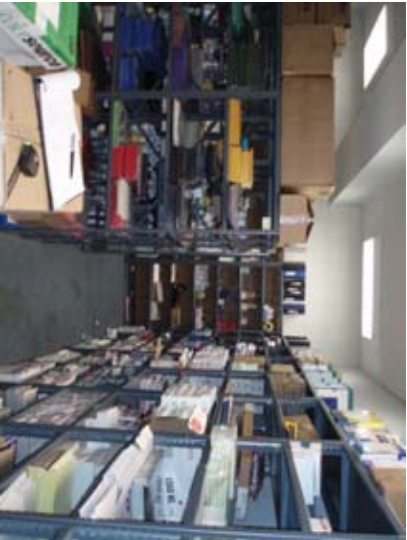
Figure 1 – These storage shelves are braced together or anchored to the walls and are unlikely to overturn. The contents on the shelves, however, can fall out.

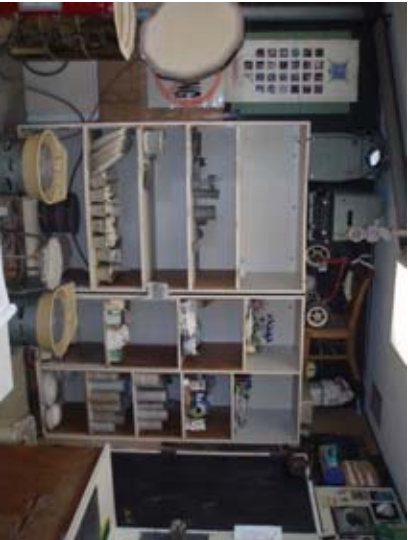
Figure 2 – Some unrestrained contents stored on the tops of storage cabinets. These are falling hazards in the exit way from the room.

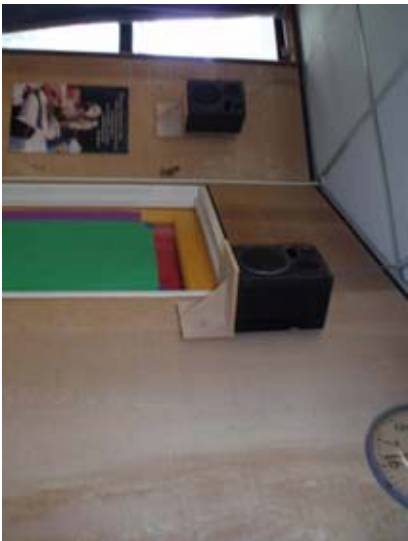
Figure 3 – These small speakers in Room 321 of the Building A are unrestrained and can become falling hazards during an earthquake.

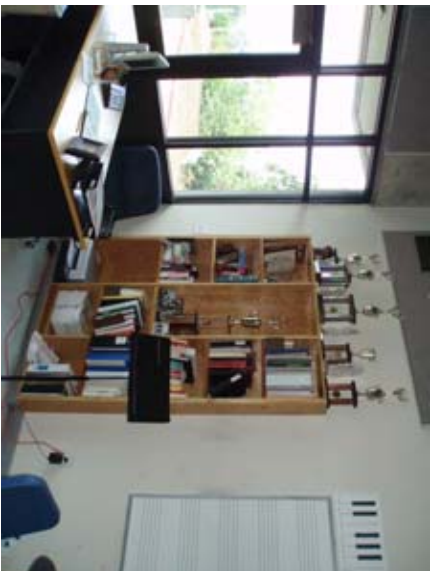
Figure 4 – The trophies stored on the top of the bookshelf behind this desk in the Gymnasium/Music building are a falling hazard.

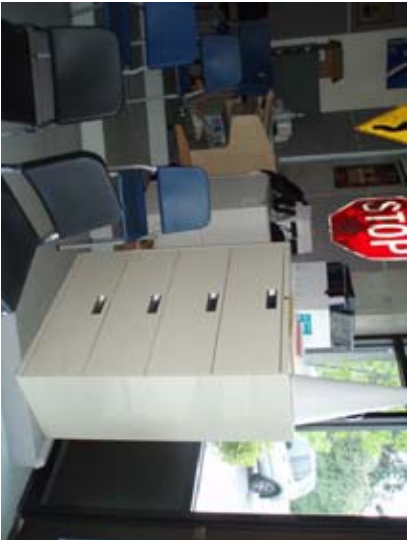
Figure 6 – This lateral file in Room 502 of the Gym/Music building does not have drawer locks and can easily top over.

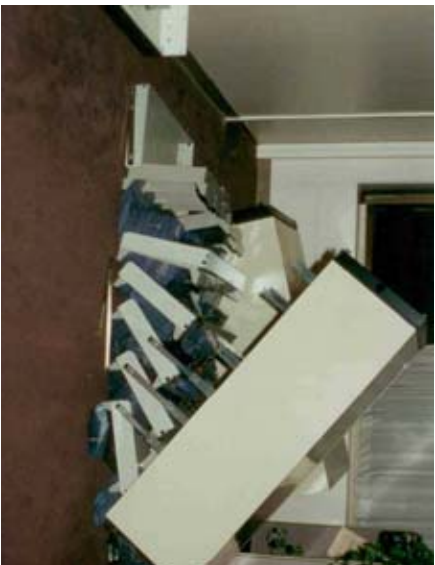
Figure 7 – This file cabinet did not have drawer locks and overturned in a San Jose office building during the 1989 Loma Prieta earthquake.

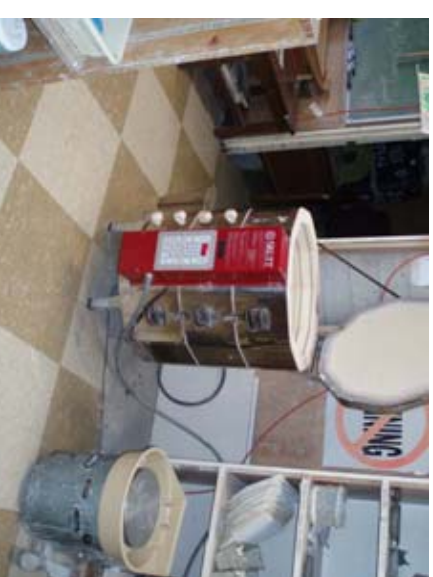
Figure 10 – Unanchored kiln in Room 122 of the Building A.
