# **WILDWOOD ELEMENTARY SCHOOL**

**PIEDMONT UNIFIED SCHOOL DISTRICT**

**SEISMIC STRENGTHENING PROGRAM / MEASURE E BOND PROGRAM**

## **INVESTIGATION AND ANALYSIS, AND CONCEPT DESIGN FINAL REPORT**

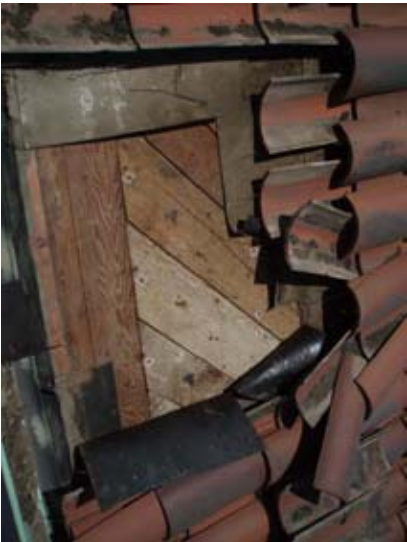
Figure 7 – Detail of edge nailing of 1 x 6 diagonal sheathing. Only one nail per board (nails are clinched) was found. Three are required. This is a serious deficiency and needs to be investigated further.

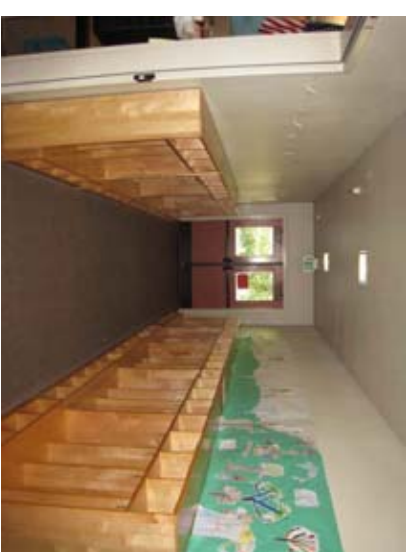
Figure 12 – These wood "cubby hole" cabinets are not anchored to the walls and may fall over in an earthquake, blocking the exit way from the lower level of Building C.

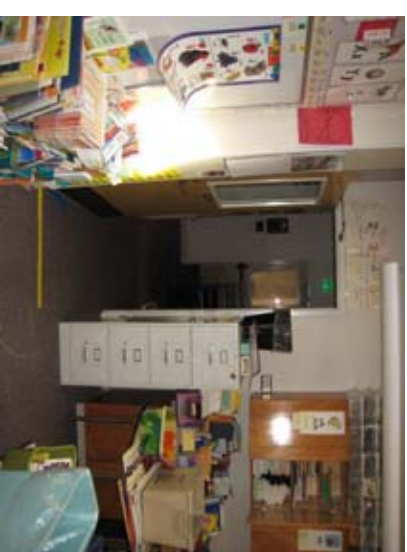
Figure 13 – This file cabinet can easily tip over and block the exit from the room.

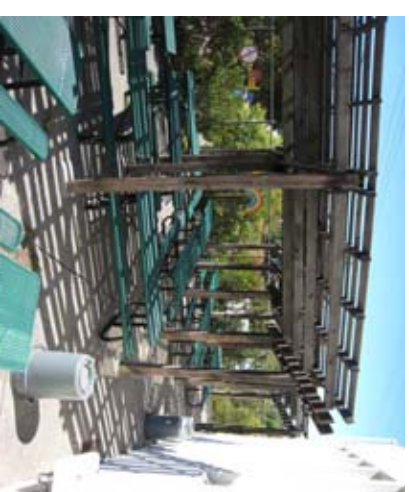
Figure 21 – Trellis over dining benches at the front of the school.

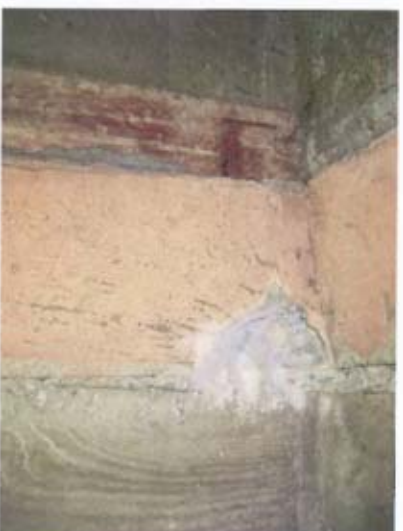
Photo 4.  
Stucco layer between  
two foundations.

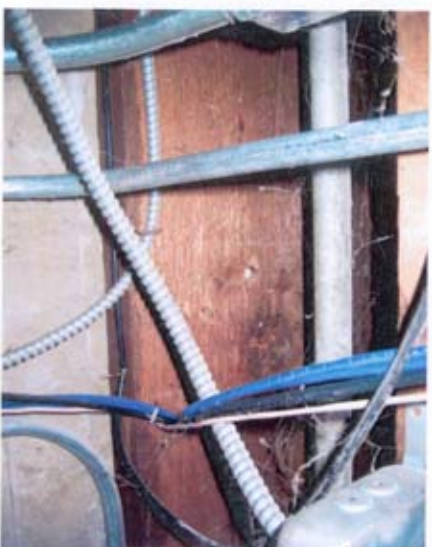
Photo 10.  
Hole drilled through  
ledger.  
Note: Location of  
anchor bolt, right side  
of drilled hole.

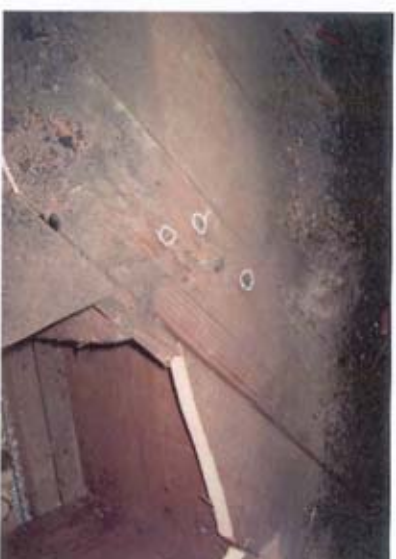
Photo 11.  
Nails found in  
diagonal sheathing at  
Line 20.

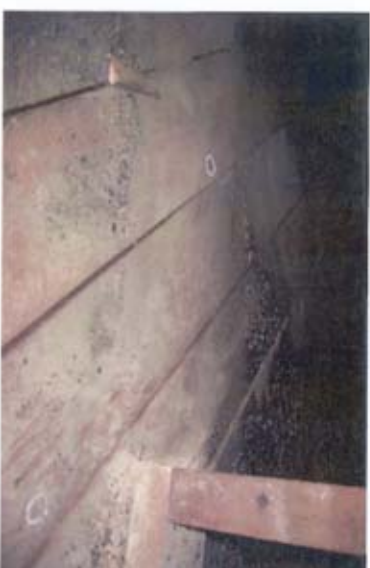
Photo 12.  
Nails found in  
diagonal sheathing at  
Line H.

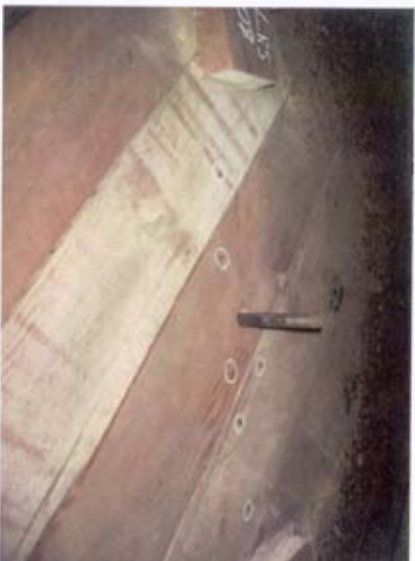
Photo 13.  
Nails found in  
diagonal sheathing at  
Line D.1

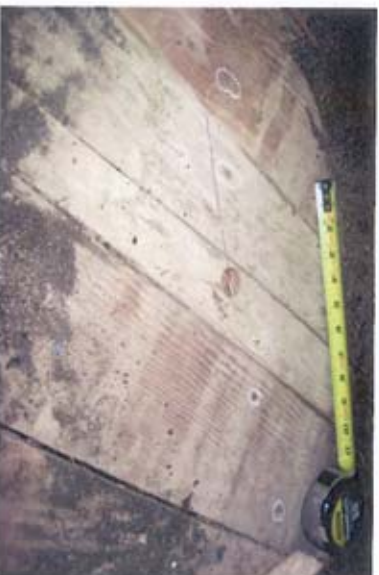
Photo 14.  
Nails found in  
diagonal sheathing at  
Line 6.1

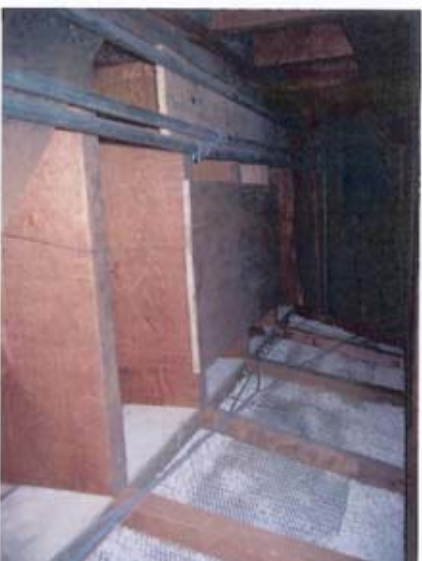
Photo 17.  
Note missing diagonal  
sheathing adjacent to  
skylight, along wall  
Line 3.
