FRANK C. HAVENS ELEMENTARY SCHOOL
PIEDMONT UNIFIED SCHOOL DISTRICT
Seismic Strengthening Program / Measure E Bond Program

COMBINED INVESTIGATION & CONCEPT DESIGN REPORTS
FINAL REPORT

March 18, 2008

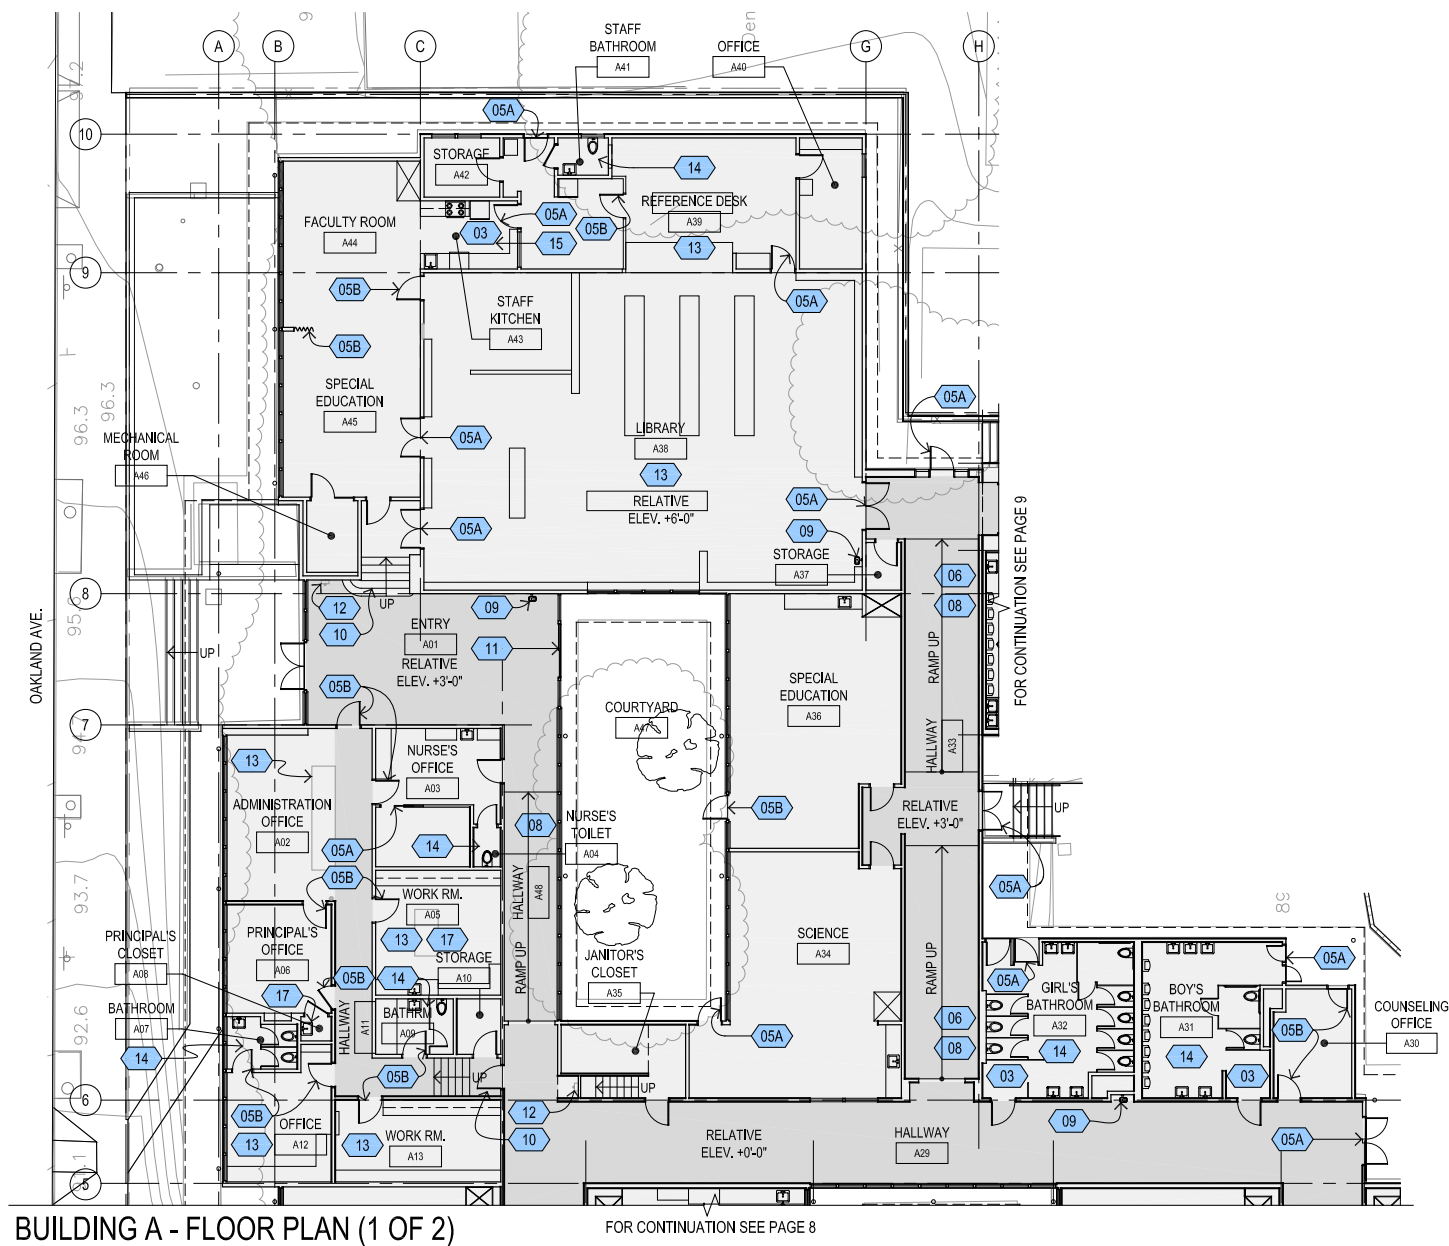
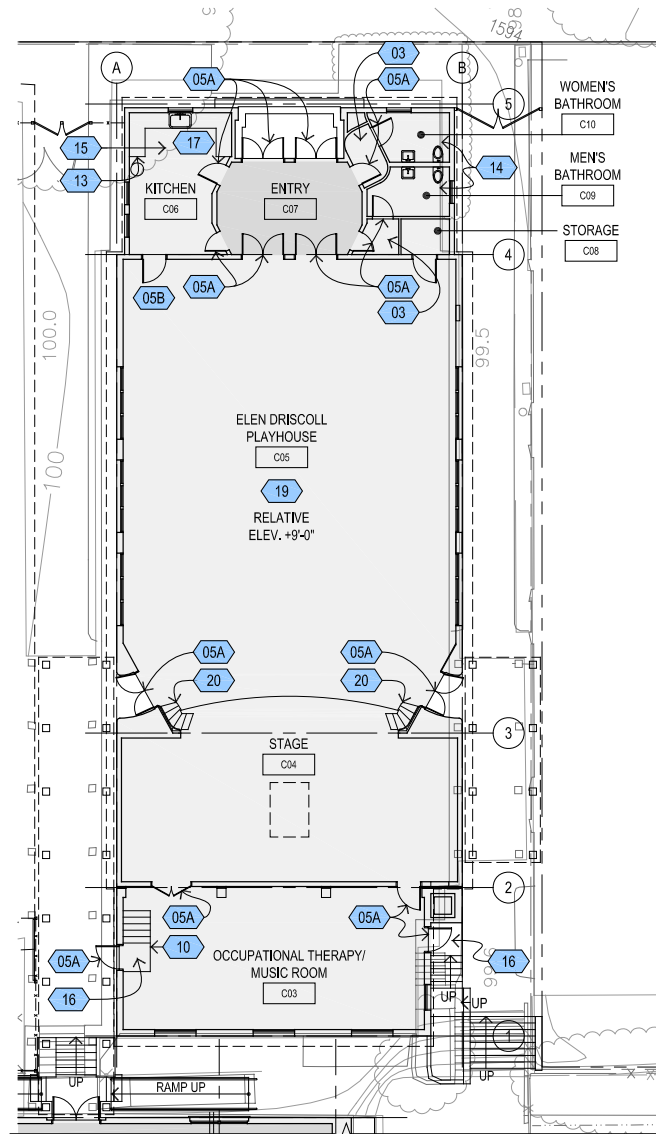
BUILDING C - FLOOR PLAN

Building C is an A occupancy (Assembly) and is required to be of one-hour construction throughout, and it is not. The side exits are classified as "exit courts" and do not meet the requirements for exit courts.

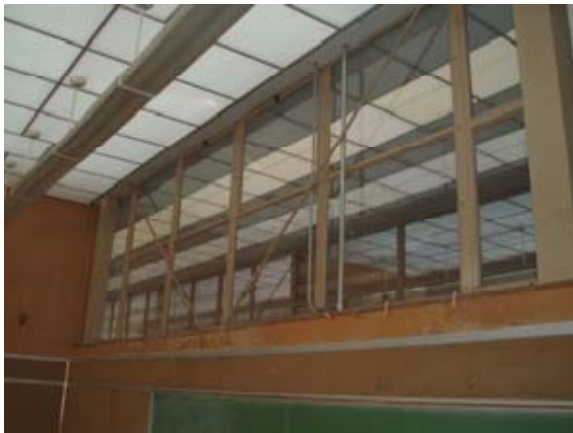
Figure 2 – Interior of a classroom wing showing rod bracing adjacent a corridor. Four bays of bracing, two on each side of the corridor, provide the longitudinal seismic resistance. Note the overhead glass in the corridor wall.

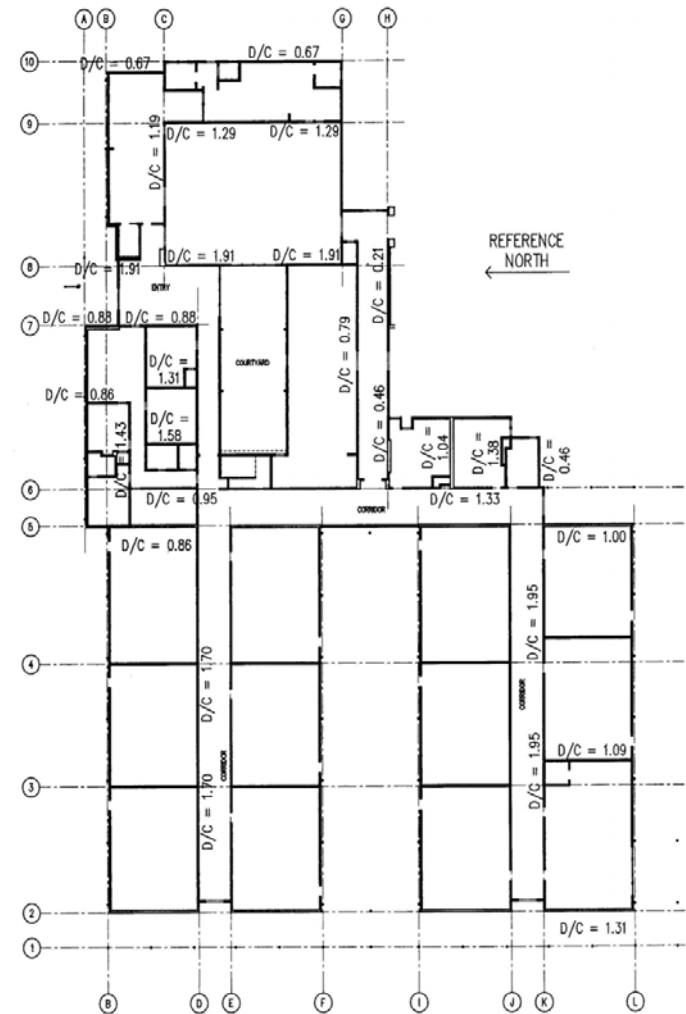
Results of the shear wall and rod bracing evaluations are summarized in Figure 3. D/C ratios for walls and bracing are indicated next to each on the plan. The most deficient elements in the classroom wings are the rod bracing in the south wing. The D/C is 1.95 in tension. In the north wing, it is 1.70. Because the bracing is tension-only and can fail suddenly, this situation is very hazardous.

Figure 3 – Floor plan of Building A. Demand to capacity (D/C) ratios for the principal shear walls and the rod bracing are also shown.

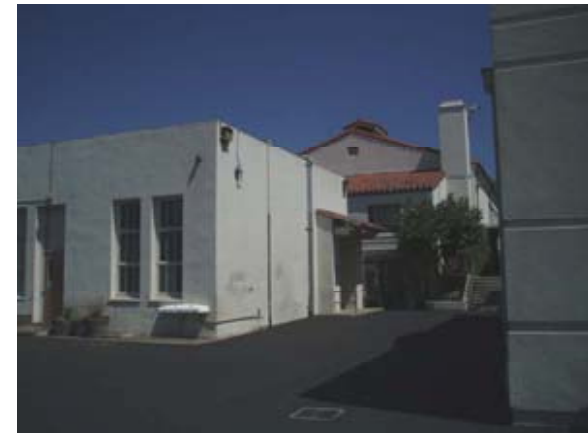
Figure 5 - South end of Building B.

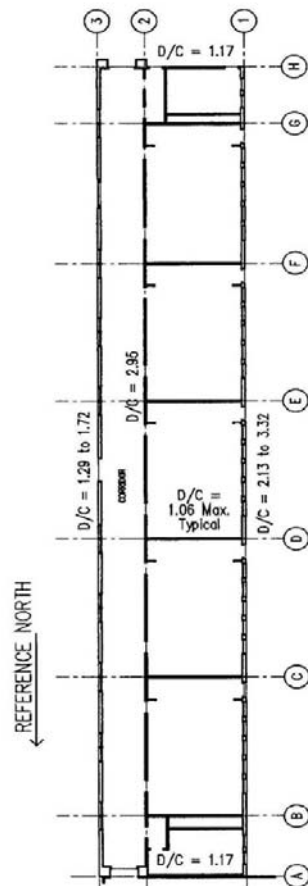
Figures 4 and 5 show views of the building, and Figure 6 provides a floor plan. Figure 6 also shows demand to capacity (D/C) ratios for the principal shear walls.

Lateral forces in both directions are resisted by diagonally sheathed shear walls. Interior transverse shear walls have 1 x 6 diagonal wood sheathing on both sides of the wall. Exterior walls have 1 x 6 sheathing only on the exterior. In the longitudinal direction, the two exterior walls are penetrated by many window and door openings (see Figure 4), reducing the effectiveness of these walls as shear walls. The original drawings indicate that the interior west wall of the corridor lacks diagonal sheathing.

Figure 6— Floor plan of building B. Demand to capacity (D/C) ratios for the principal shear walls are also indicated.

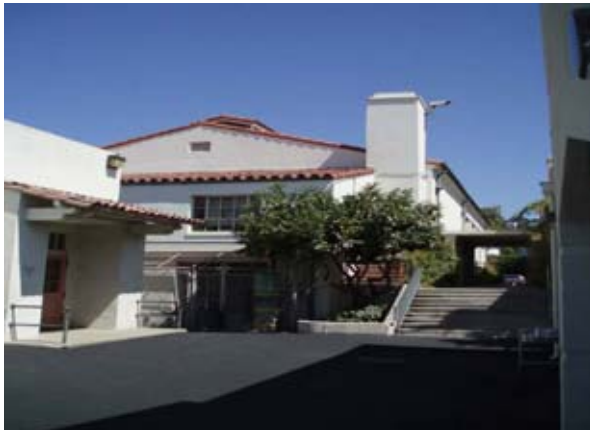
The concrete portion at the rear of the building was briefly investigated for the Tier 2 criteria and found acceptable. The concrete chimney located at the S/W corner of the structure was also found to meet criteria.

Figure 8 - Rear of Building C showing the concrete portion of the building. The chimney shown has reinforced concrete construction.

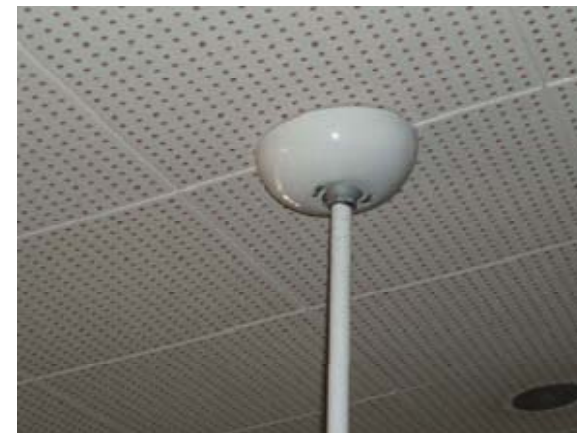
Building A has overhead pendant fluorescent light fixtures in a number of rooms, including classrooms and the library. There are also some in the Buildings C and D. These typically hang down from the ceiling on a metal tube stem of about 1 to 3 feet in length. Most of the fixtures have a partial ball and socket swivel at the top (Figure 10) and one-directional rotating socket at the bottom of the stem (Figure 11). These fixtures have capacity to move laterally in both horizontal directions. Some have wires that restrain movement in one horizontal direction but not in the other. Fixtures in Building D are similar to those in Buildings A and C, except the bottom stem connection is rigid and does not allow longitudinal movement.

Figure 10 – Typical ball and swivel top connection of pendant fluorescent light fixture in Havens ES classrooms.

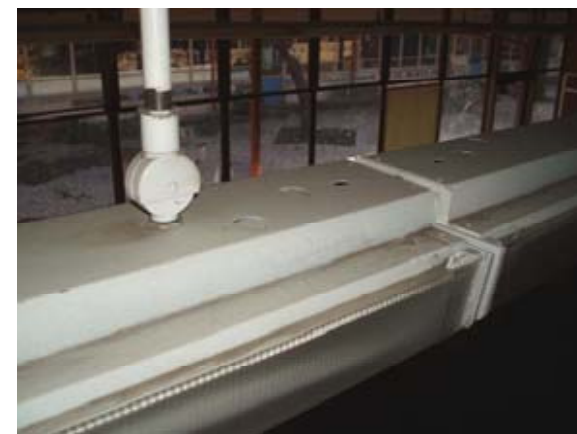
Figure 11 – Typical unidirectional swivel used on the bottom of the pendant stem in Havens ES. This detail allows stem rotation in one direction.

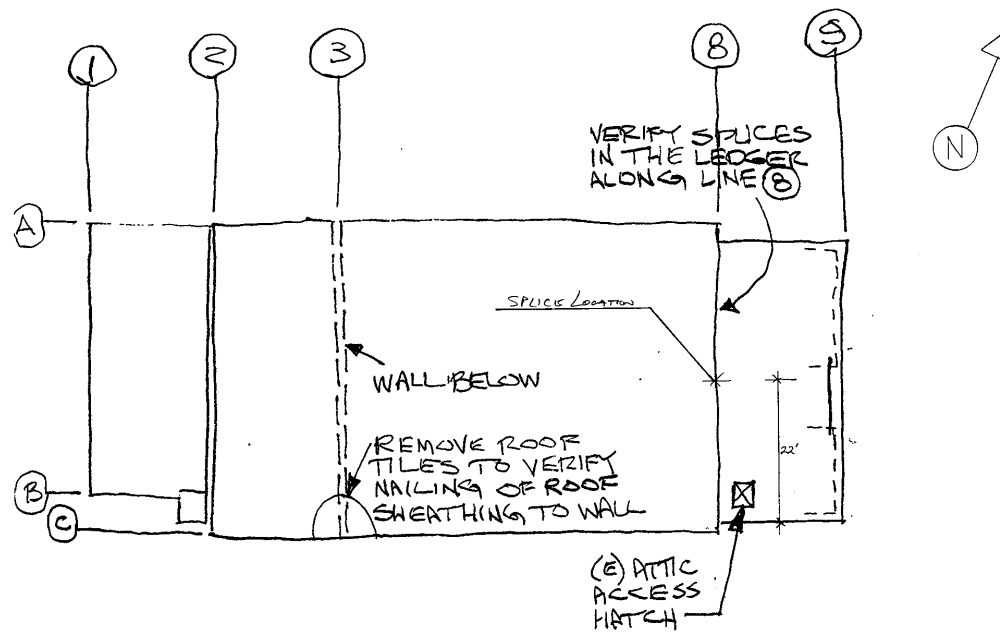
ELLEN DRISCOLL AUDITORIUM
FIGURE 1

Roof tiles were removed in order to document nail size and pattern of attachment of roof sheathing to framed wall below. Location of this investigation is shown in Figure 1.

Documentation of 2x6 ledger splice was performed in the attic of the entry at the Driscoll Auditorium. Location of ledger splice documented is shown in Figure 1.
