**MAINTENANCE BUILDINGS**  
**PIEDMONT UNIFIED SCHOOL DISTRICT**  
**SEISMIC STRENGTHENING PROGRAM / MEASURE E BOND PROGRAM**

**INVESTIGATION AND ANALYSIS**  
**FINAL REPORT**

# MAINTENANCE BUILDINGS

# INVESTIGATION AND ANALYSIS

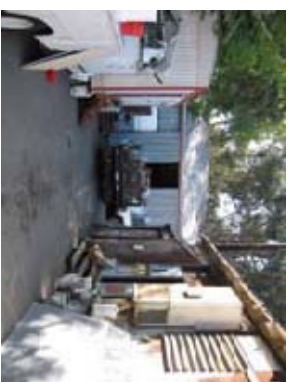
Main driveway into corporation yard

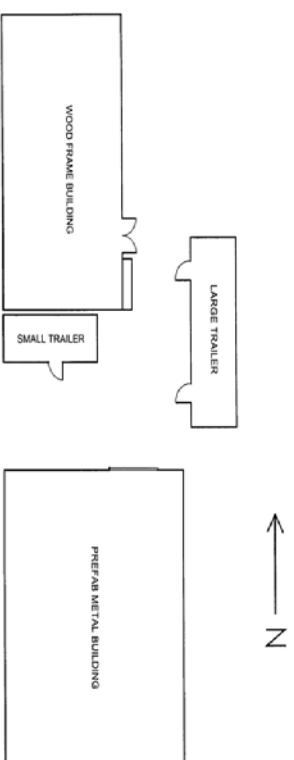
Figure 1 – Corporation yard site plan showing the approximate layout of buildings.

There are two buildings at the yard (Figure 1). Both are reported to have been relocated to the site from other places. One is a 1,320 sf wood frame structure, and the other is a 1,980 sf prefabricated metal building. These are used as shops and offices.

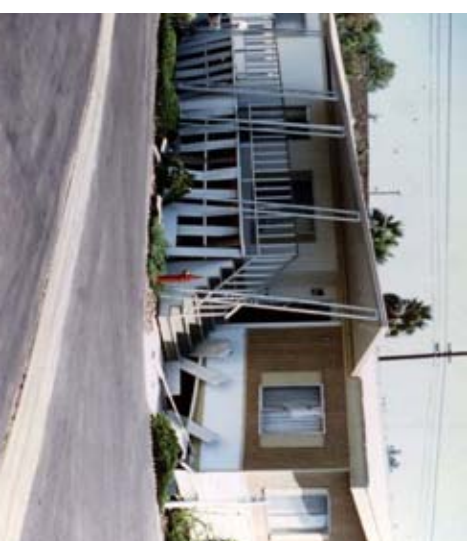
Figure 8 – An example of a trailer (mobile home) that has fallen off its supports.

The large trailer does not meet the Tier 1 criteria because it lacks foundation anchorage. Trailers and mobile homes without anchorage frequently fall off their supports in earthquakes (see Figure 8). While the life safety risk is generally small, immediate use of the trailer afterwards is prevented and repairs are generally required.
