PIEDMONT HIGH SCHOOL

PIEDMONT UNIFIED SCHOOL DISTRICT

Seismic Strengthening Program / Measure E Bond Program

COMBINED INVESTIGATION & CONCEPT DESIGN FINAL REPORTS FOR FOUR NON-PRIORITY BUILDINGS

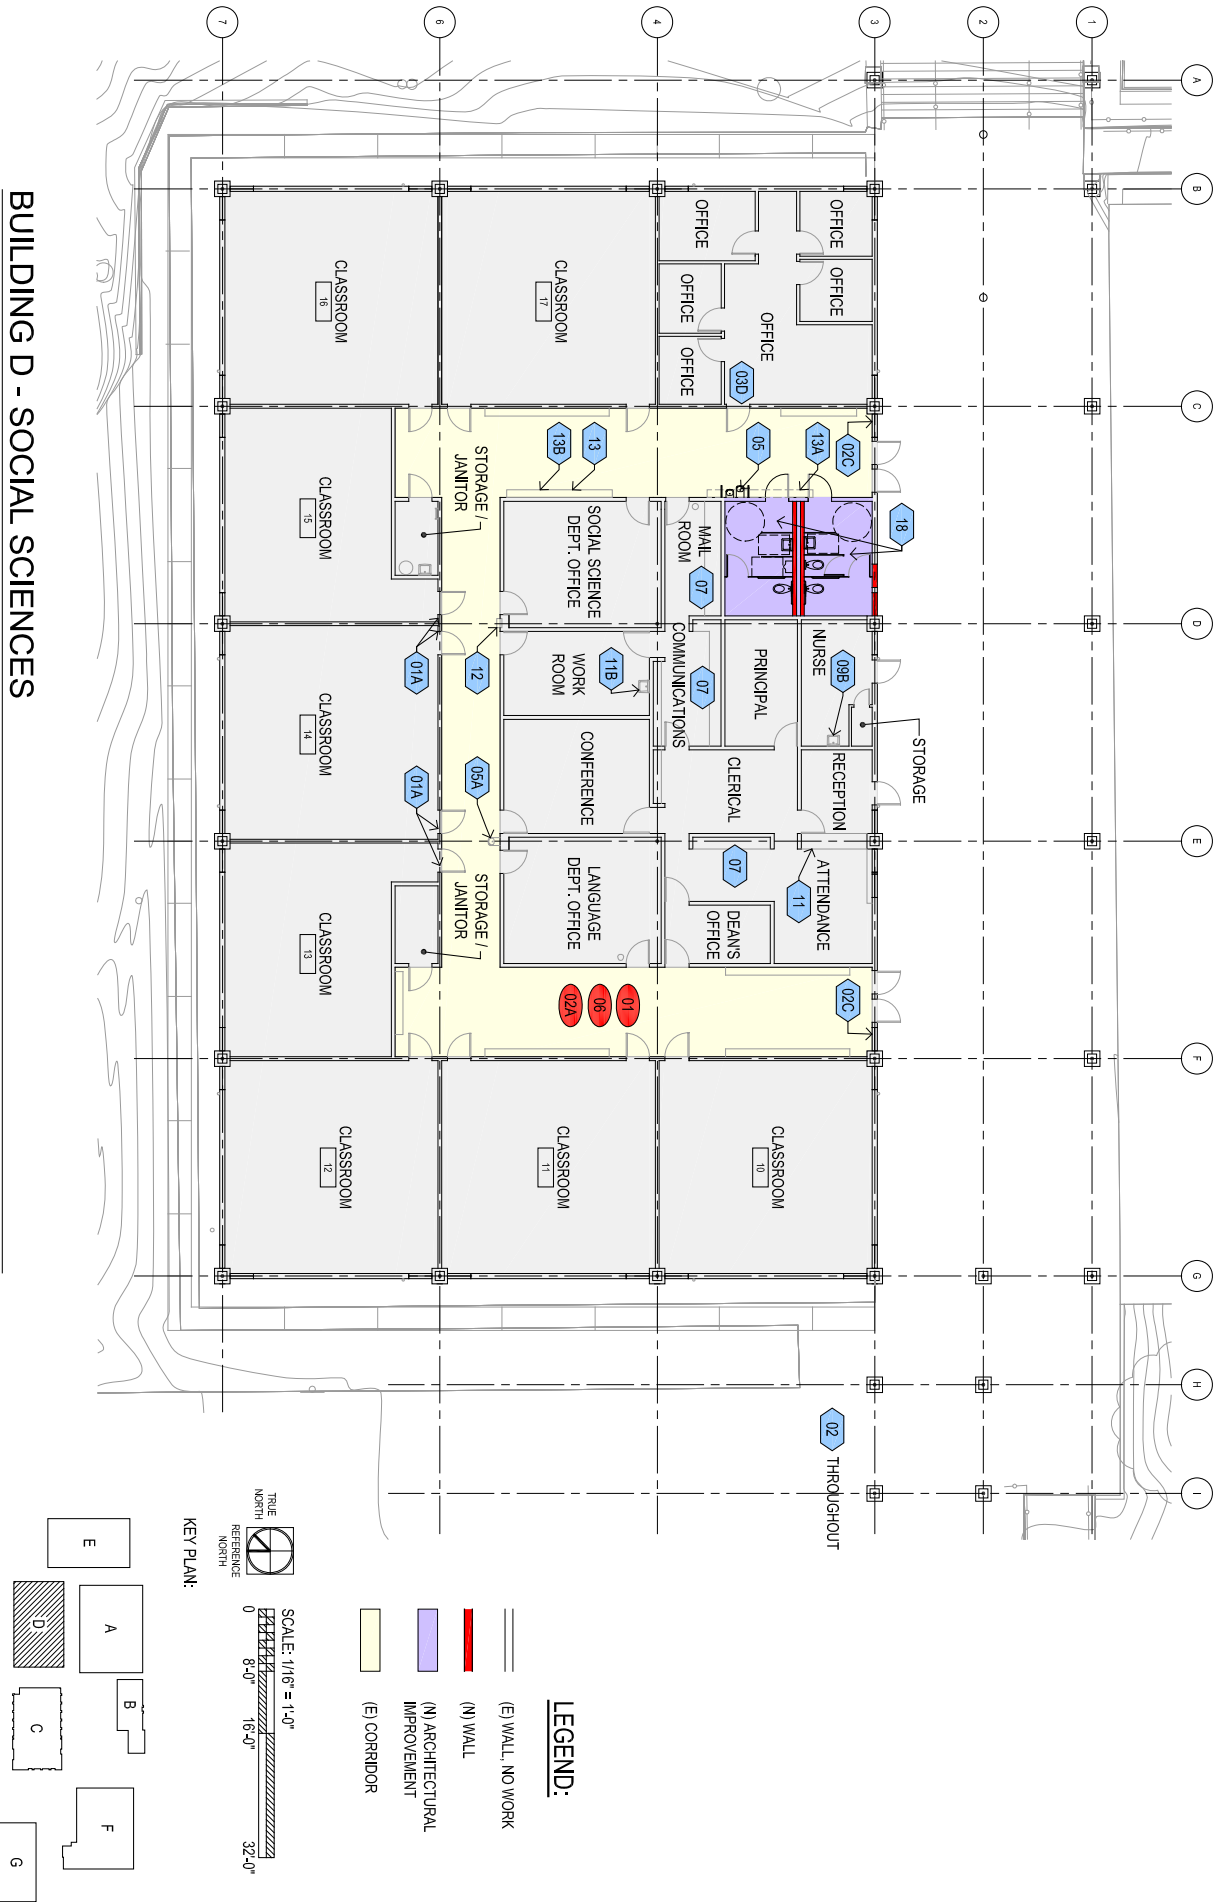
BUILDING D - SOCIAL SCIENCES

The minor accessibility issues include correction of deficient room door clearances, providing accessible room and directional signage, correction of protruding fixtures and equipment, provisions for accessible counters and sinks, and provisions for accessible lockers.

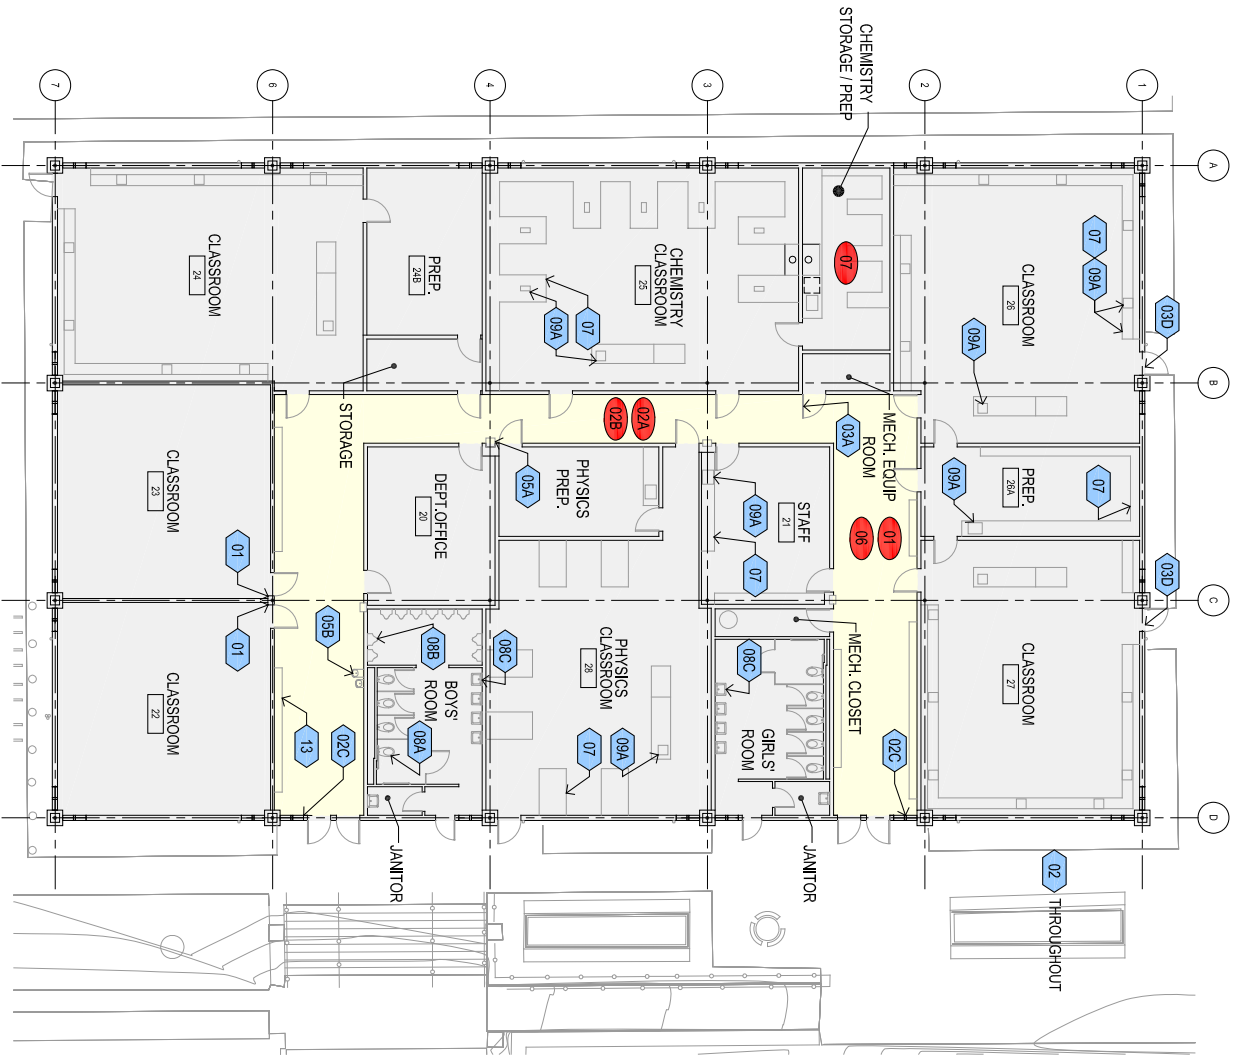
BUILDING E - SCIENCE

Building E has similar minor issues as Building D, including correction of deficient room door clearances, providing accessible room and directional signage, correction of protruding fixtures and equipment, provisions for accessible counters and sinks, and provisions for accessible lockers. The Science Building toilets will need some modifications to bring them into compliance, but the general layout remains unchanged.

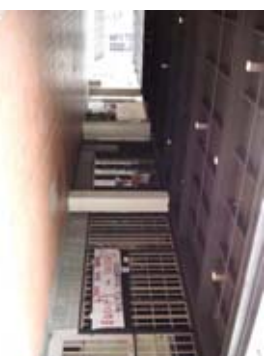
Many of the exterior stairs are not compliant, lacking handrails on one side or intermediate railings, lacking proper extensions, and/or lacking proper contrasting striping on the stair treads. The ramps are lacking guide rail edge protection. The diameter of most of the handrailing is non-compliant.

Covered Thoroughfare between Bldg. A & D

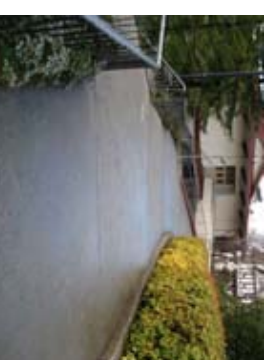
Ramp and Entry to Building G

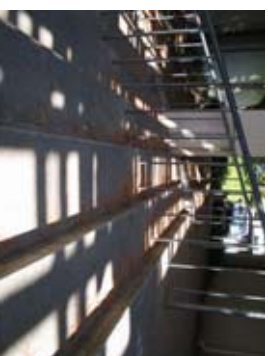
Stairs between buildings D & E

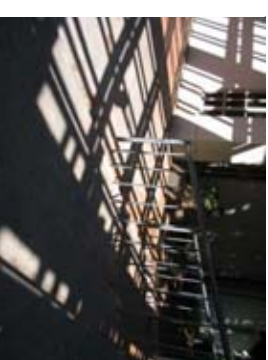
Stairs between buildings D & E

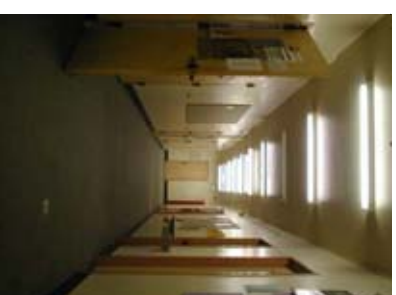
Building D - many of the doors have non-compliant "dog-leg" hardware.

- B. ROOM SIGNAGE
 - C. TACTILE EXIT SIGNAGE
- ◀03▶ DOOR HARDWARE:
 - A. DOOR HANDLE: REPLACE WITH LEVER TYPE
 - B. REPLACE EXISTING THRESHOLD
 - C. REMOVE EXISTING DOG-LEG HARDWARE

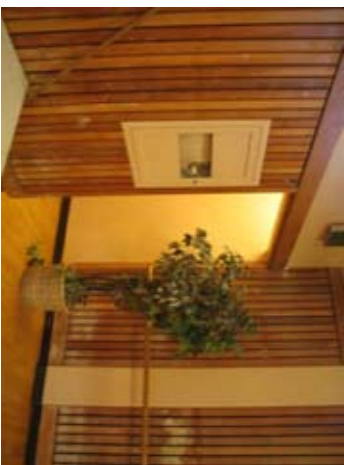
Building F - existing fire hose cabinet.

- ◀01▶ PROVIDE FLOOR LEVEL EXIT LIGHT SYSTEM.
- ◀02A▶ PROVIDE NEW FIRE SPRINKLER SYSTEM.
- ◀02B▶ PROVIDE NEW FIRE ALARM SYSTEM.
- ◀03▶ PROVIDE ROOM CAPACITY SIGNAGE.
- ◀04▶ REMOVE FIRE HOSE, CAP SUPPLY AND PROVIDE FIRE EXTINGUISHER.
- ◀05▶ ADD (N) HANDRAIL WITH COMPLIANT DIAMETER TO ONE SIDE OF STAIRS.
- ◀06▶ REMOVE DOG-LEG DOOR HARDWARE FROM ALL CORRIDOR DOORS.
- ◀07▶ PROVIDE BRACING AND SHELF GUARDS AT ALL STORAGE SHELVES.
- ◀08▶ ADD TRAVEL RESTRICTOR TO CURTAIN ROD TO PREVENT CURTAIN FROM BLOCKING EXIT PATH; RELOCATE EXIT LIGHT TO MAINTAIN VISIBILITY.
- ◀09▶ PROVIDE FIRE-RATED DOOR AND FRAME.

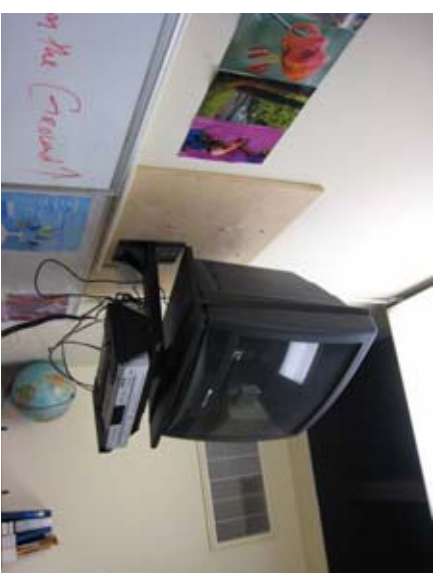
Those hung from ceilings appear to be low risk (L). Many were mounted on walls (Figures 15 and 16). These were installed by the District's maintenance staff.

Figure 15 – Wall-mounted TV in Building D.

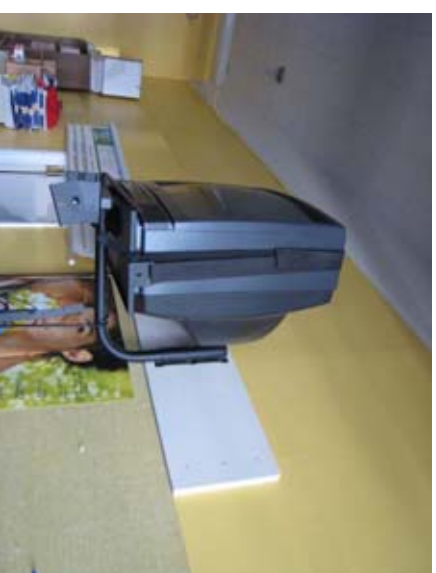
Figure 16 – Wall-mounted TV in Building G.
