**PIEDMONT HIGH SCHOOL
PIEDMONT UNIFIED SCHOOL DISTRICT
SEISMIC STRENGTHENING PROGRAM / MEASURE E BOND PROGRAM**

**INVESTIGATION AND ANALYSIS,
AND CONCEPT DESIGN
FINAL REPORT
FOR THREE PRIORITY BUILDINGS**

March 6, 2008

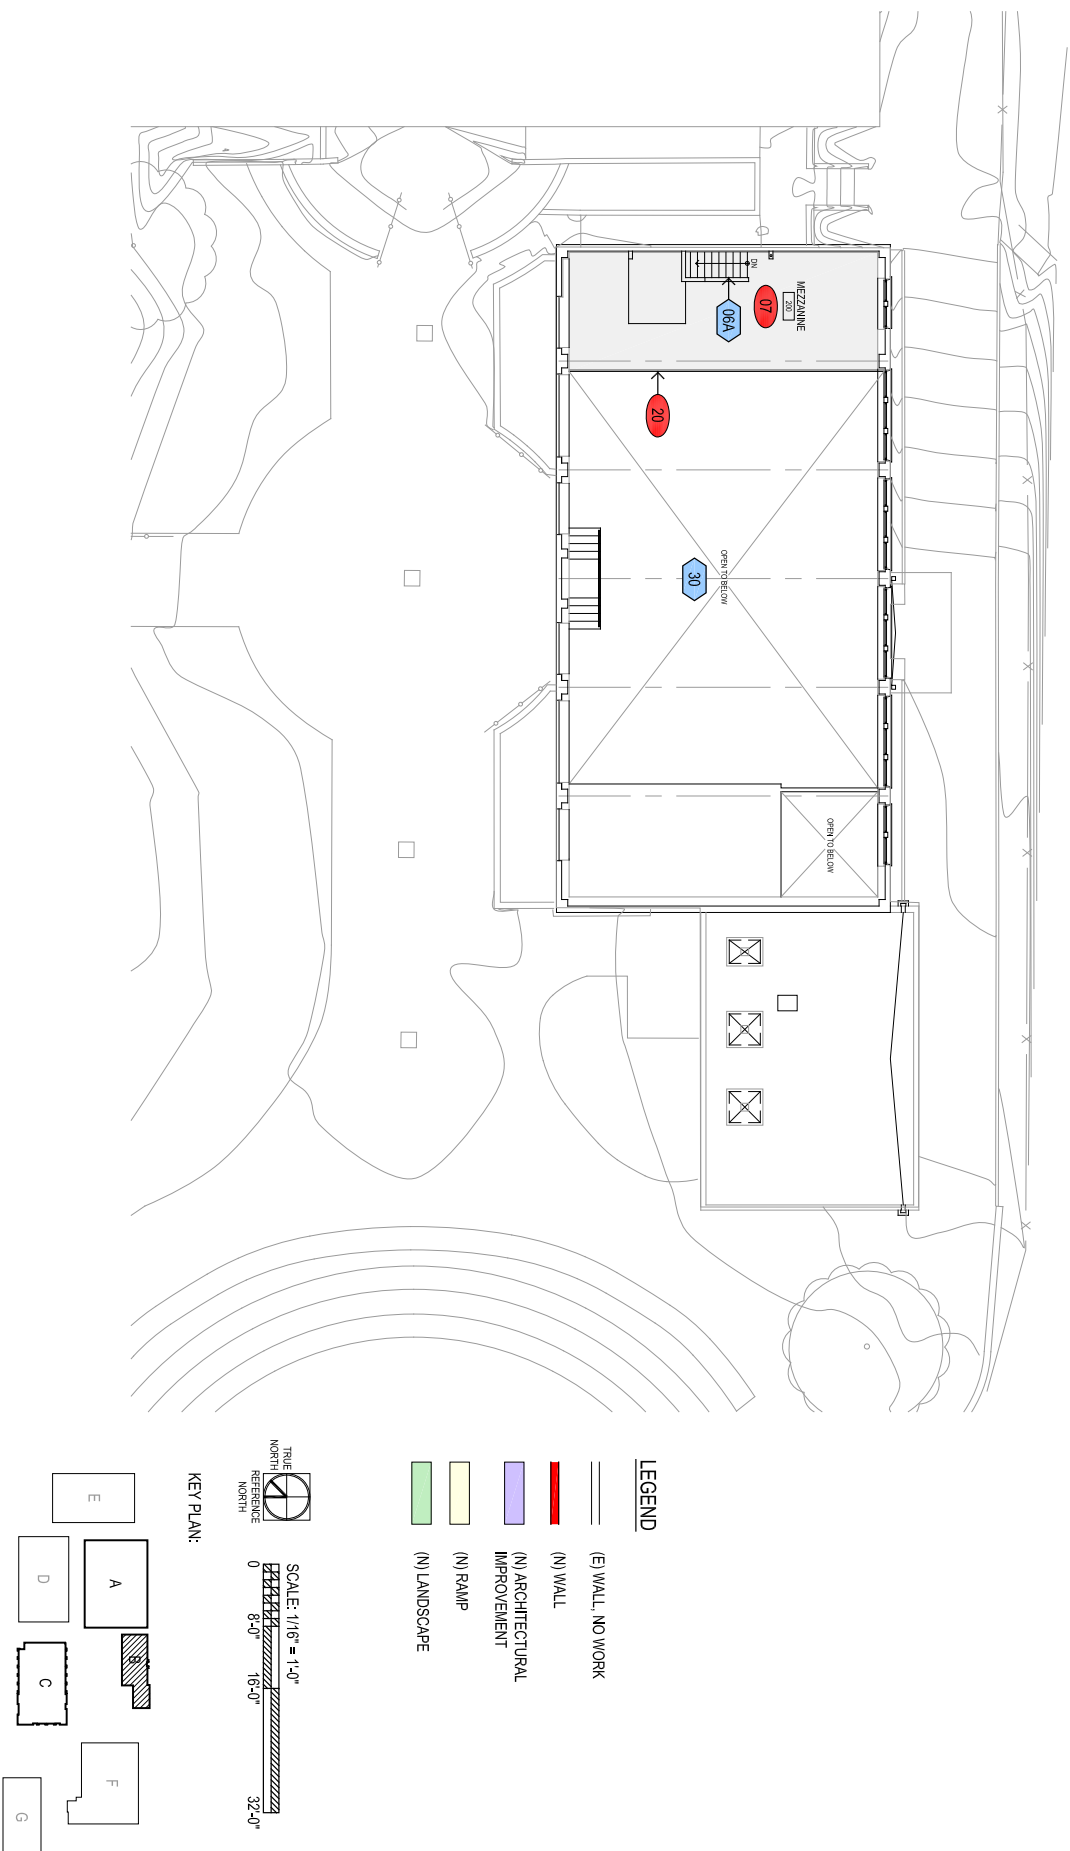
BUILDING C - MAIN LEVEL - ALLEN HARVEY THEATER - OPTION NO. 1

MAJOR ISSUES:

DSA REQUIRES 6 DISPERSED SEATS IN THE THEATER. THE CURRENT THEATER HAS 2 IN THE REAR ONLY

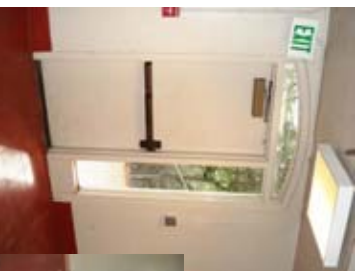
Building A - Thresholds at south side exit doors too high

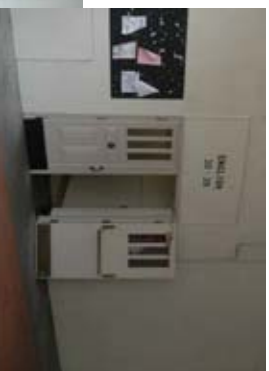
Building A - Entry doors at second floor are too narrow.

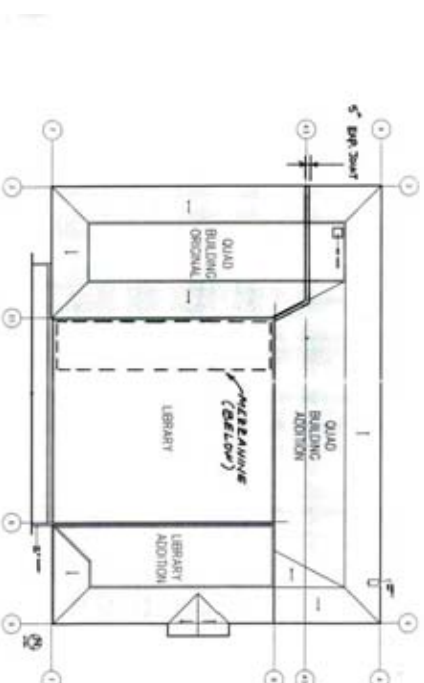
The Quad building (also known as Building A) is composed of five separate structures (see Figure 1). The original building (Figure 2), for which there are no drawings, was believed built in the 1930's. An addition to this building (Figure 3) was built a short time afterwards.

Figure 1 – Roof plan showing the five structures that make up the Quad building. The mezzanine is located within the library.

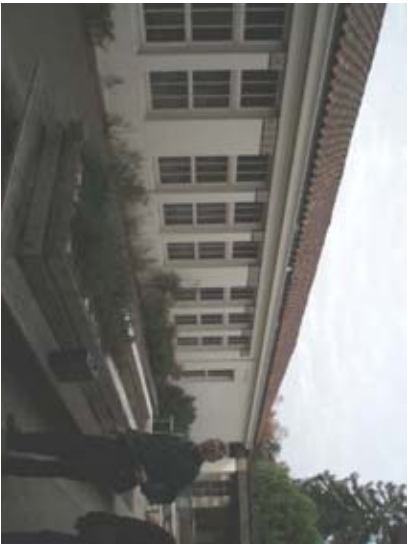
Figure 2 – One-story east side of the Quad building. Note the heavy Spanish tile roof.

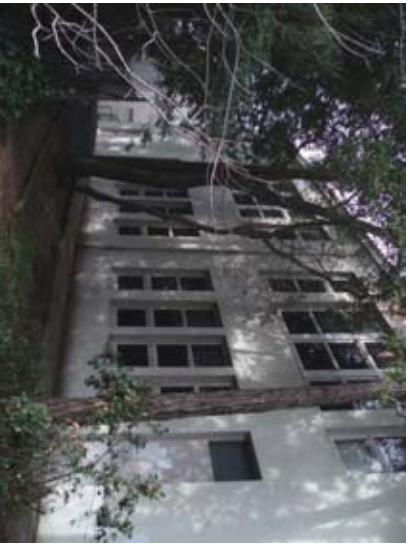
Figure 3 – Two-story south side of the Quad building.

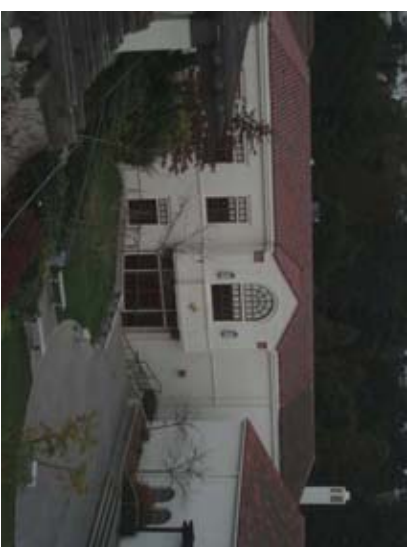
In the mid-1990's, the library addition (Figure 4) was constructed. This consisted of a two-story building west of the library and a new mezzanine located in the library adjacent the east wing of the original building. These are the fourth and fifth of the five structures that comprise the Quad building.

Figure 4 – The west entrance to the Quad building is the Library Addition.

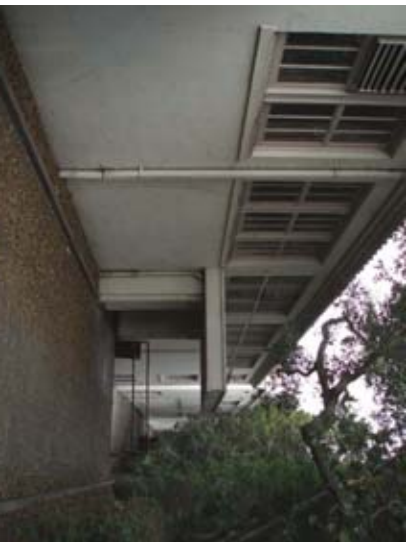
Figure 9 – Rear (south side) of the Student Center. The original windows on the north side have been infilled (see Figure 8).

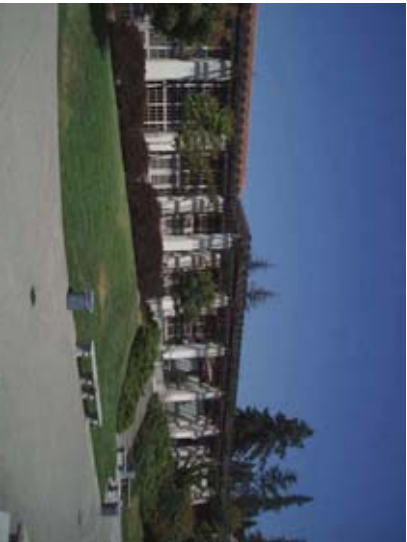
Figure 11 – South Side of the Alan Harvey Theater.

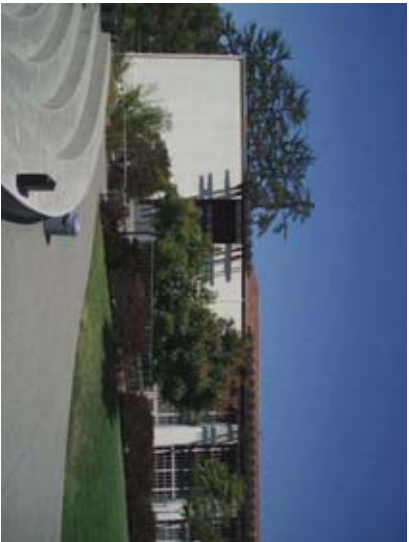
Figure 12 – Southwest corner of Alan Harvey Theater. Wall on left is a stucco wall and not a plywood sheathed shear wall.

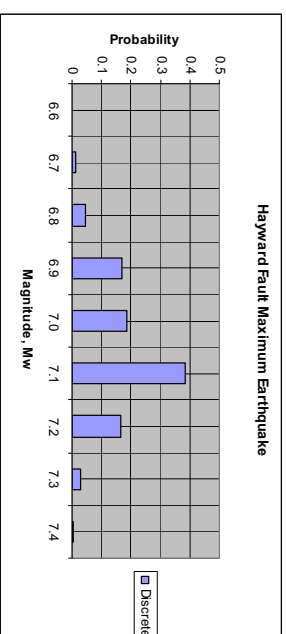
FIGURE 3

scenario occurring and probabilistic distributions for characteristic maximum earthquake magnitudes for that scenario. These scenario likelihoods and magnitude distributions were incorporated in conducting the deterministic ground motion analyses to estimate the ground shaking characteristics representative of the possible range of maximum earthquake capability of the Hayward fault near Piedmont; this possible range of maximum earthquake capability is illustrated on Figure 3.

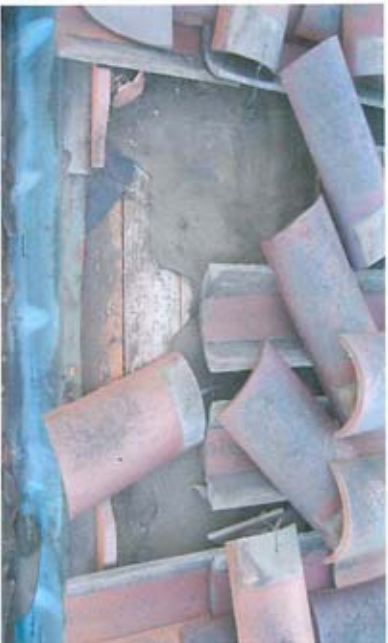
The method of attachment of roof tiles was determined at four (4) locations (RT1 through RT4). Locations (approximate) of roof tile examination are shown in Figure 3. See Photo 1 for typical roof tile attachment.

Photo 1: Typical roof tile attachment.

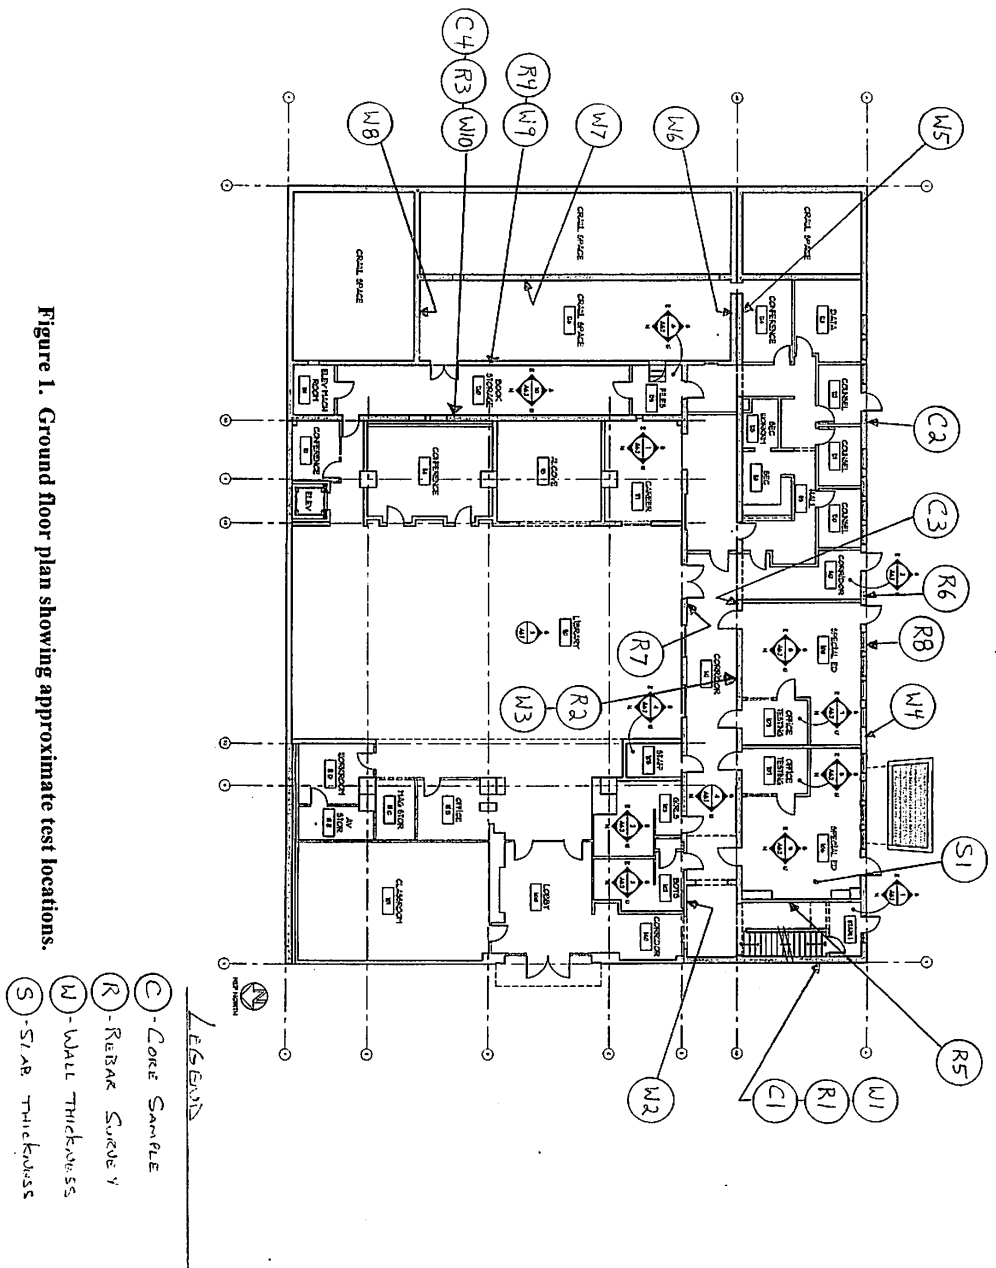
A total of nine (9) concrete core samples (C1 through C9) were removed and tested for compressive strength per ASTM C42 (dry). Locations (approximate) of removed cores are shown in Figures 1 and 2.

A pachometer and GPR (radar) equipment were used to survey spacing of reinforcing steel and number of curtains at nineteen (19) locations (R1 through R19). In addition, exposures were made for determination of reinforcing size and concrete cover. Locations (approximate) of steel survey and exposures are shown in Figures 1 through 3.

Wall thickness was determined at nineteen (19) locations (W1 through W19). In addition, slab thickness was determined at five (5) locations (S1 through S5). Locations (approximate) of thickness measurements are shown in Figures 1 and 2.

Figure 1. Ground floor plan showing approximate test locations.

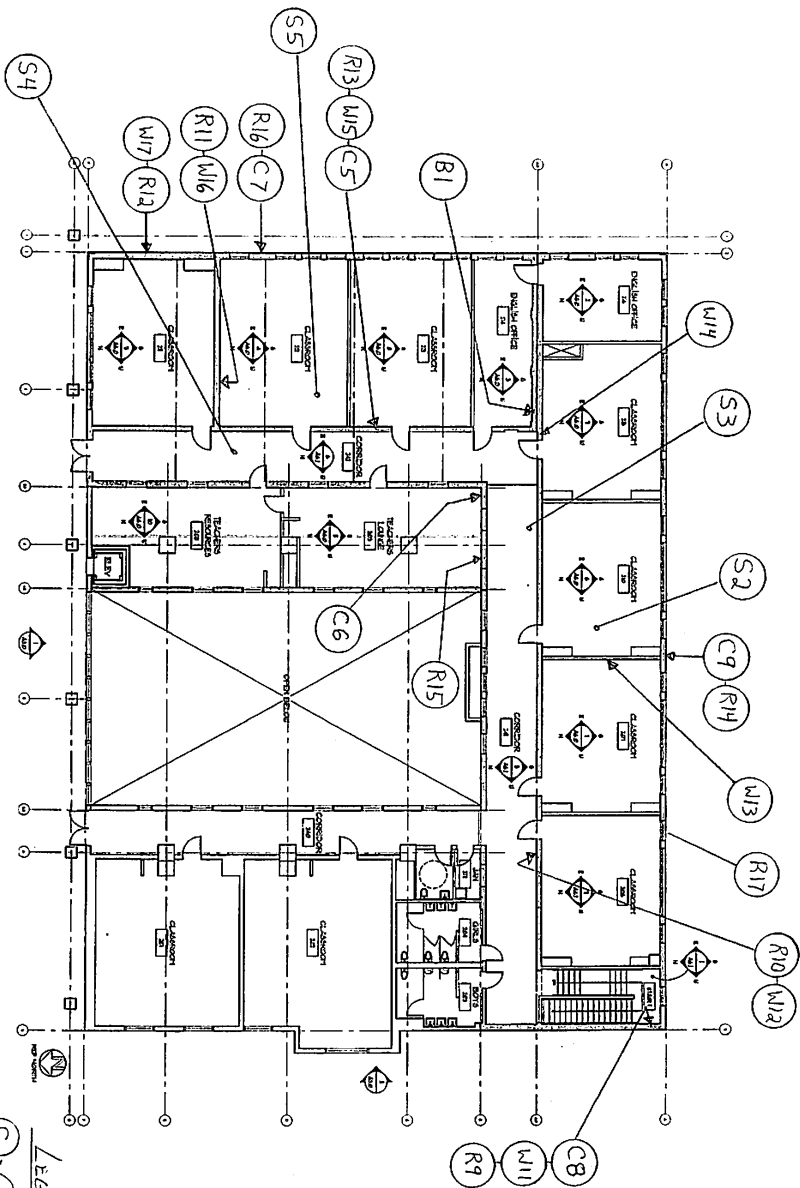
Thickness of the in-fill brick wall was determined by drilling a 3/8" diameter hole through the wall at one (1) location (B1). In addition, exposures were performed to determine reinforcing size, spacing, and doweling into adjacent concrete. Location of in-fill wall examined is shown in Figure 2.

Figure 2. Second floor plan showing approximate test locations.

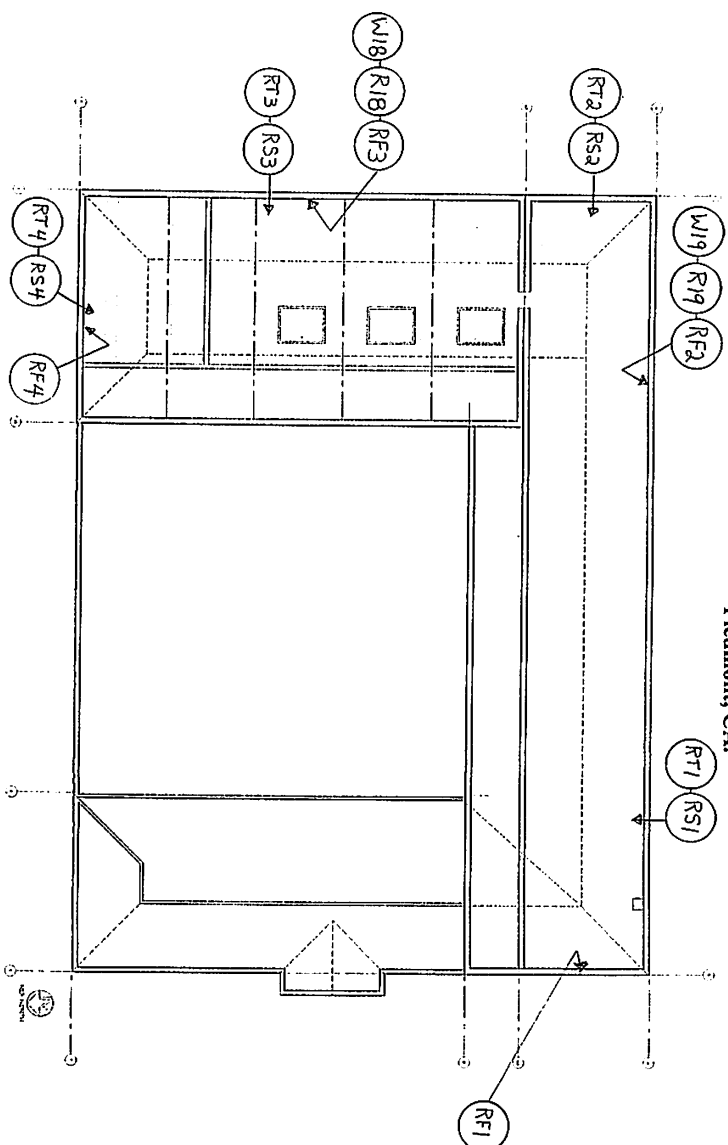
Exposures were performed at four (4) locations on the roof (RS1 through RS4) to determine roof sheathing type, nailing pattern and nail size. Locations (approximate) of roof sheathing exposures are shown in Figure 3. See Photo 2 for typical sheathing observed.

Documentation of roof framing to wall connection was performed at four (4) locations (RF1 through RF4). Locations (approximate) of roof framing/wall connection are shown in Figure 3.

Figure 3. Attic/roof plan showing approximate test locations.
