# **WILDWOOD ELEMENTARY SCHOOL**

**PIEDMONT UNIFIED SCHOOL DISTRICT**

**SEISMIC STRENGTHENING PROGRAM / MEASURE E BOND PROGRAM**

## **INVESTIGATION AND ANALYSIS, AND CONCEPT DESIGN FINAL REPORT**

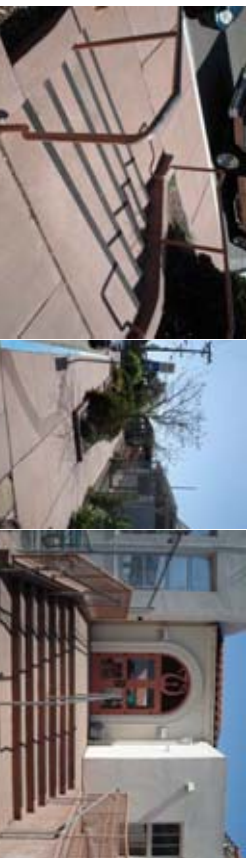
Steps to main entrance from Wildwood Ave.

Ramp to main entrance

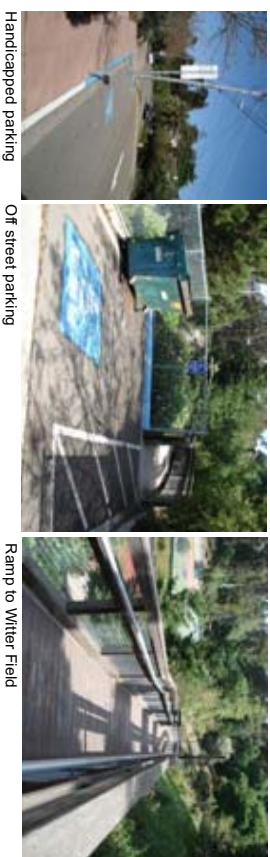
Handicapped parking

Off street parking

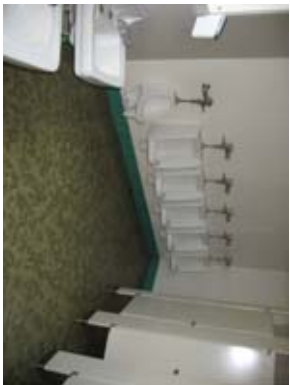
Code compliant boys' restroom

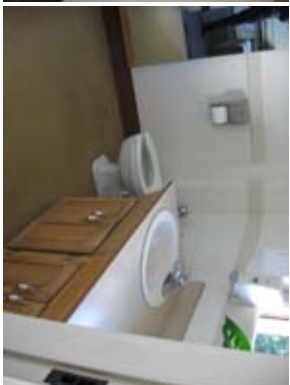
Non compliant staff restroom

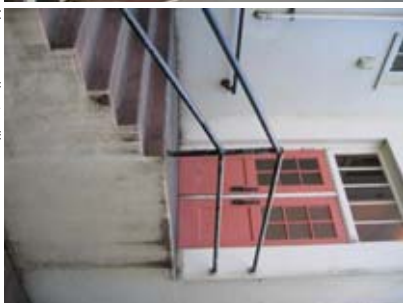
Non compliant railings

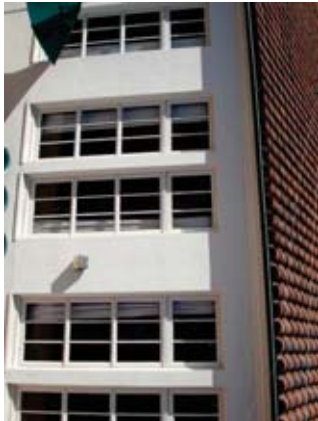
View of exterior wall

Of primary concern is the fact that the northwest exterior wall of the 1930's classroom wing is within 10'-0" of the property line. Table 5-A requires that openings within 10'-0" of the property line are protected. There are existing windows in this wall that are not protected. In addition, the main corridor in the old classroom wing, built in the 1930's, is not code compliant. This corridor, which provides the primary exit pathway for the classrooms in this area, was never brought up to the required one hour fire rating. The doors to the classrooms are non-rated wood doors and frames. Openings to the corridor here are non-rated as well. Fire sprinklers were added in this corridor when the 1995 project was built,

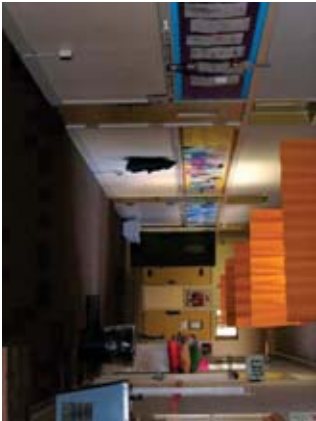
Non-compliant corridor

to mitigate this condition. Based on the extent of the new work in this area, and other factors, DSA may require this corridor to be upgraded to meet current codes.

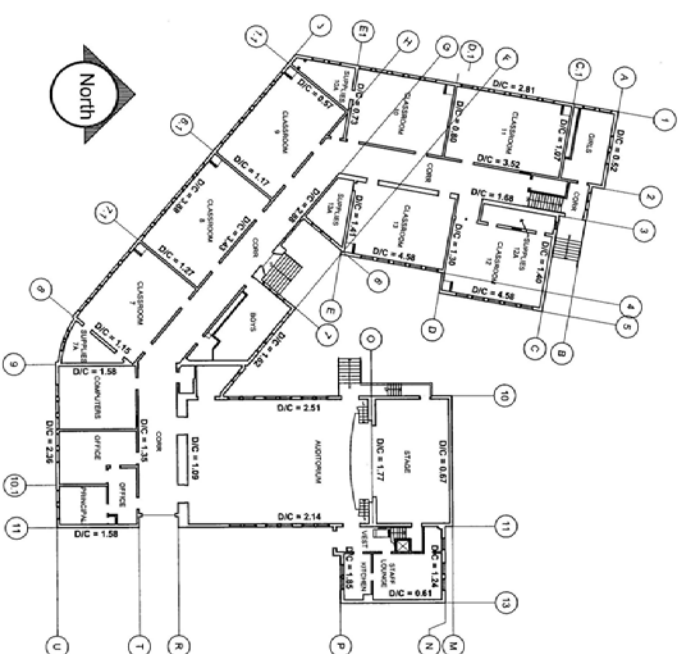
- (1) Building A (classroom wing) – The building does not meet the ASCE 31 Tier 2 life safety criteria. Many of the shear walls are significantly overstressed in shear. While we do not believe the building is a collapse hazard, it appears to be very damageable. A major contributor to its seismic deficiencies is the fact that its exterior walls have many openings for windows and doors.

- (2) Building B (auditorium) – The auditorium does not meet the ASCE 31 Tier 2 life safety criteria. Its east, west and proscenium shear walls are significantly overstressed. Field investigation revealed an area on the roof having incomplete nailing of the diagonal sheathing, the extent of which needs to be determined by further exploration. This building is also not believed to be a collapse hazard.

Figure 1 – Plan showing the original 1930's building (Buildings A and B) at Wildwood School. Demand to capacity ratios ( $D/C$ ) for the shear walls are also shown.

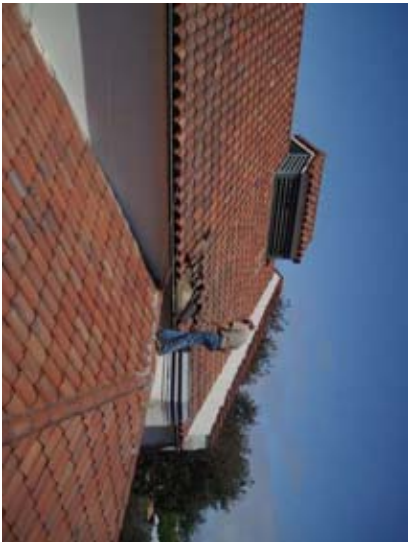
**Building B.** Provided the missing nailing is installed (see Figures 6 and 7), the shear strength of the diagonally sheathed roof diaphragms was found to be adequate. The D/C ratios varied from 0.36 to 0.92. These numbers are based upon the assumption that the proscenium wall on Line O is effective in resisting seismic forces. The diaphragm chord construction is not known, so their capacities could not be evaluated. At Beach and Havens Auditoriums the chord D/C's along the sides were 1.1 and 2.0 respectively. So they do not offer any guidance for an estimate at Wildwood.

Figure 6 – Exploration opening in the roof of the auditorium.

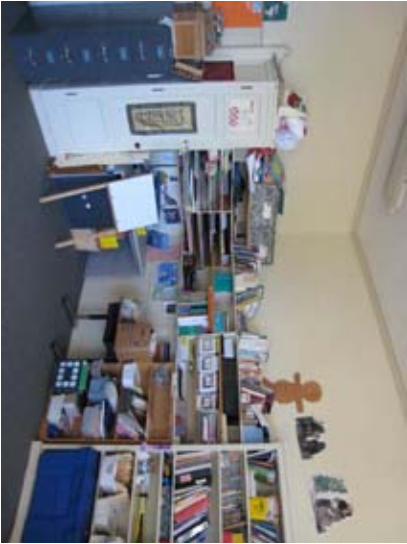
In addition to the survey results given in Tables 3, 4 and 5 it should be noted that in virtually all areas of the school there are unrestrained contents (see Figures 8, 9 and 10 for some examples). These include such things as stored materials and books on shelves, and computer monitors on desks. While these are a threat to fall to the floor and may result in economic loss, they are generally not considered serious life-safety-hazards. Exceptions are

Figure 8 – “Ad hoc” storage in a classroom. The two storage boxes to left of corner are resting on a board supported by two unrestrained concrete blocks.

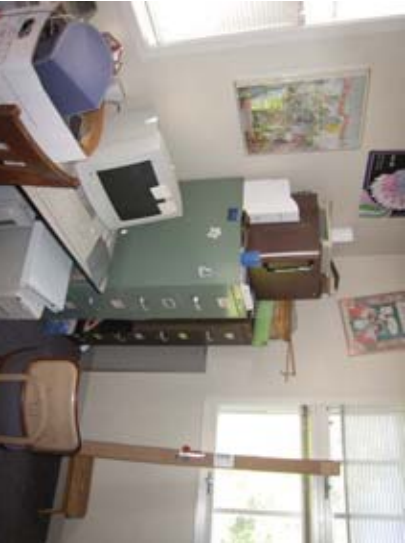
Figure 9 – An unrestrained small refrigerator on top of file cabinets in the Library workstation. This can easily fall off.

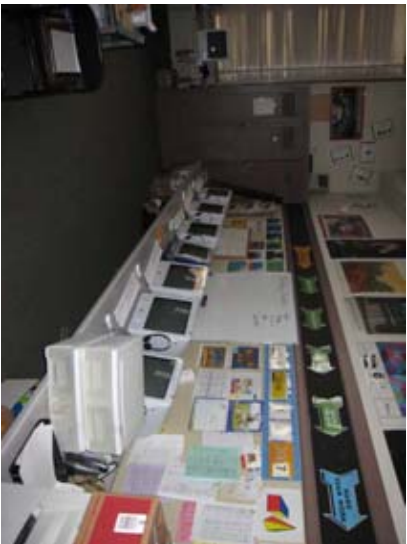
Figure 10 – Unanchored computers in the computer room.

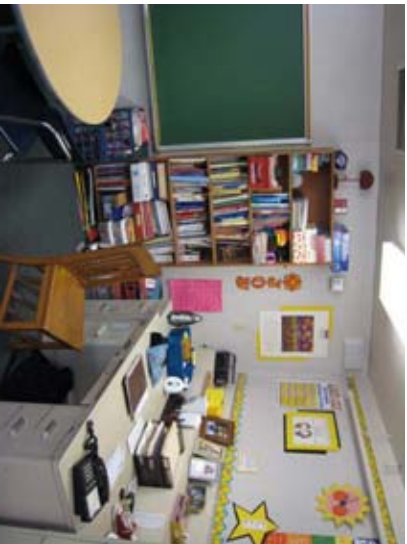
There are bookcases and storage cabinets located throughout the school. Most of these are secured to walls and are unlikely to overturn, although contents may fall out. A few cabinets and bookcases are free-standing and unanchored (see Figures 11 and 12). Those over 4 feet tall with height to depth ratios of 3.0 or greater are considered a hazard to overturn under ASCE 31 criteria (Ref. 1). It should be noted that the State of California recommends a different height criteria. It recommends that bookcases more than three feet high be placed back to back and fastened together or be secured to a wall (Ref. 2).

Figure 11 – Unanchored tall bookcase in Classroom 15.

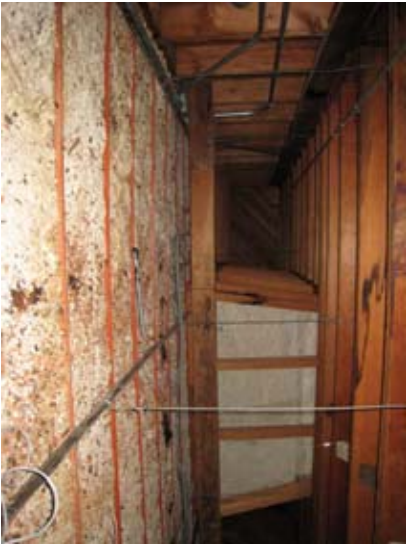
Ceilings in the older Buildings A and B are mostly plaster. The corridor ceiling at the main level is plaster on metal lath. The lath is wired to 1-inch channels, and the channels are supported by heavy gage wire connected to the roof joists (Figures 14 and 15). While this does not meet ASCE 31 Tier 1 criteria because it is not braced every 12 feet, the risk of the ceiling falling is believed to be low.

Figure 14 – View of plaster ceiling construction above the corridor at the main level in Building A. Ceiling is connected to roof joists by hanger wires spaced at approximately 4 feet on center.

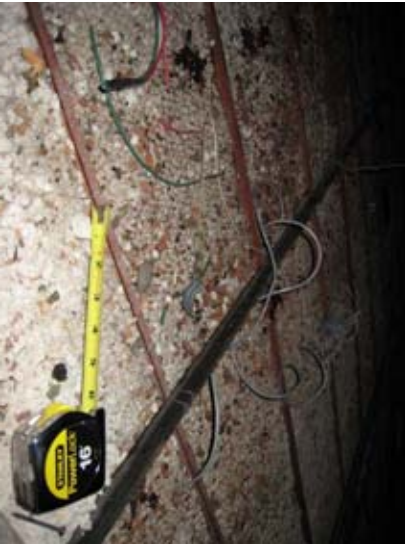
Figure 15 – Close-up of attachment of metal lath to 1-inch channels.

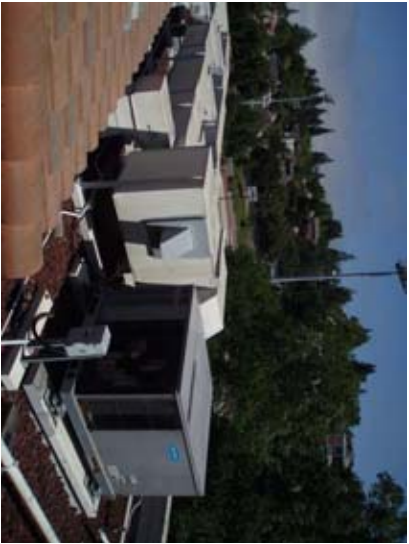
The buildings have gas lines that supply gas to roof top HVAC units (Figure 16), heaters in classrooms, oven/ranges, and boilers. The roof top lines are generally anchored to the roof, but the provision for relative movements at building seismic separation joints may be

Figure 16 – Mechanical units on the roof are anchored and have flexible gas lines.

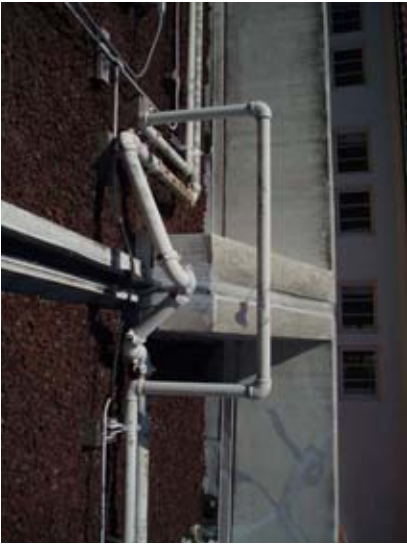
questionable (see Figure 17). Other than the lines on the roof, we were unable to observe most lines because they are concealed. The lines on the roof range in size from 1 to 2-1/2 inches in diameter.

Figure 17 – The gas line (at top) and the sprinkler line (bottom) pass over seismic separation joint on the roof. The provision for relative movement between the two structures may be questionable, particularly for the gas line.

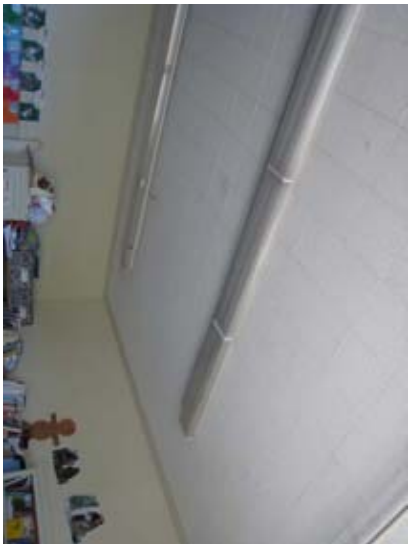
Overhead fluorescent light fixtures with heavy ballasts can be a falling hazard if not adequately secured. As part of the nonstructural survey, fixtures in each room were examined. The school has several different types of fixtures. Ceiling-mounted fixtures (Figure 18) are considered low risk. Cable-hung fixtures (Figure 19) are also considered low risk. Pendant-type large incandescent or gas vapor fixtures (Figure 20) can be a hazard if they are not restrained or are not resistant to shaking.

Figure 18 – Ceiling-mount fluorescent light fixtures. These are typically secured directly to wallboard or plaster. There have been few reports of these falling in an earthquake.

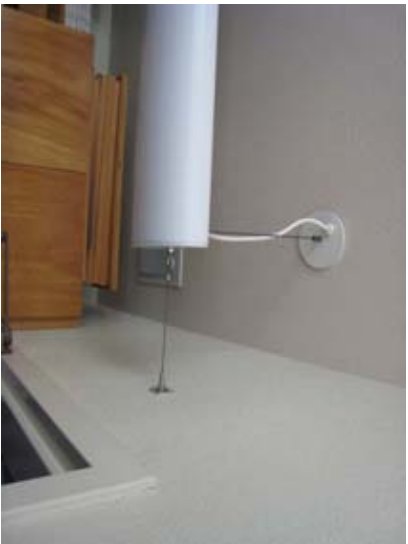
Figure 19 – Examples of new cable-hung fluorescent fixtures in the Multi-Purpose room.

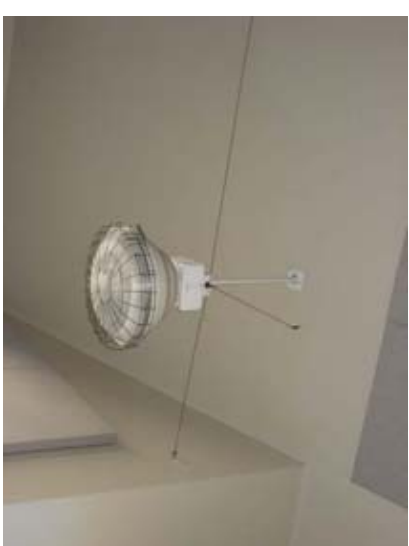
Figure 20 – Well-restrained light fixture in the Multi-Purpose room.

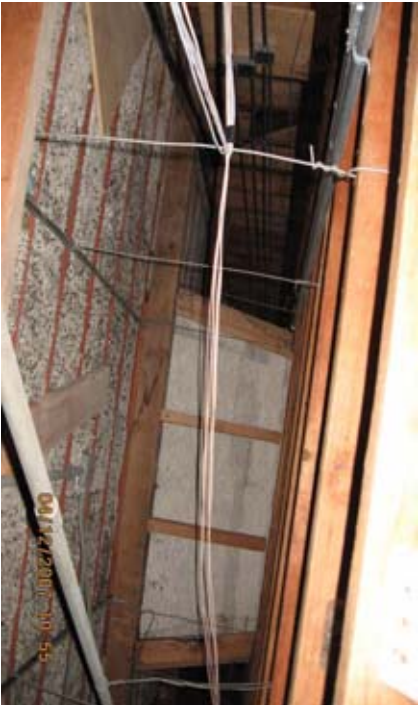
Photo 1. Suspended ceiling viewed from grid line R, looking towards grid line X.

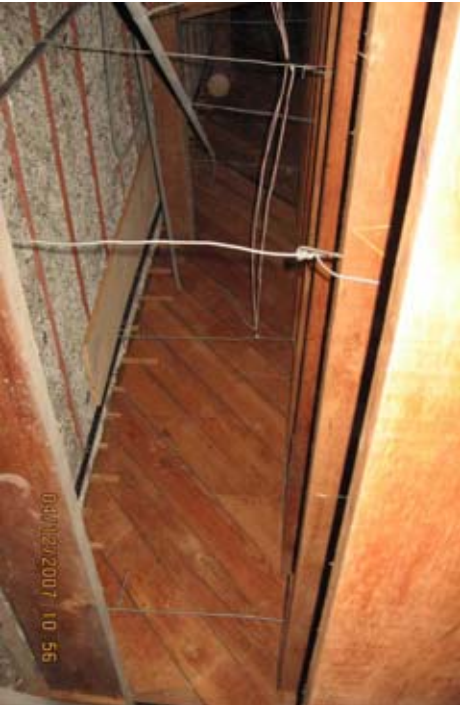
Photo 2. Suspended ceiling view from grid line R, looking towards grid line S.

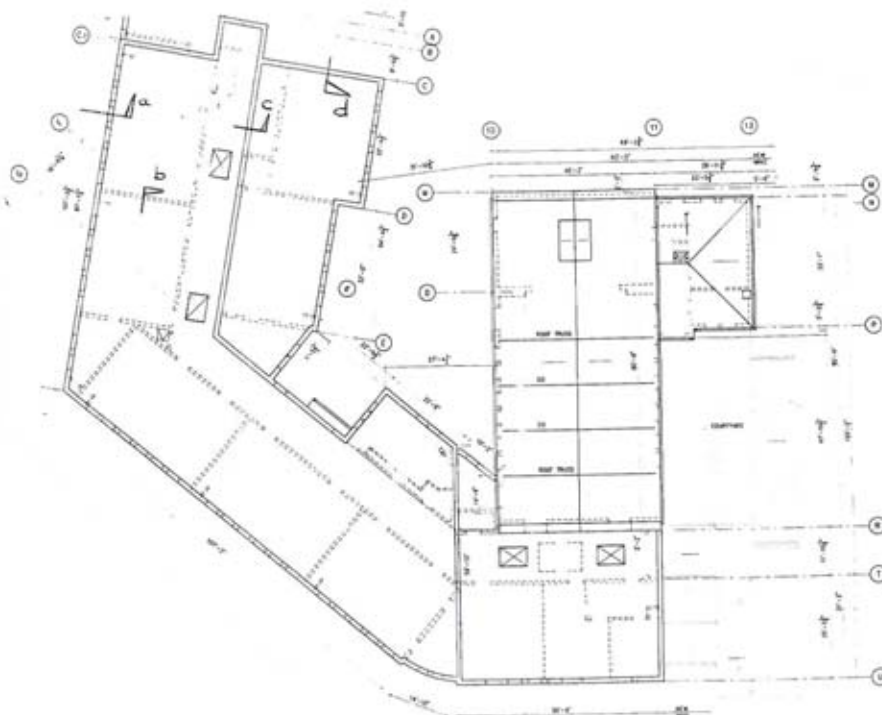
Figure 1. Roof plan showing approximate ceiling explorations.

*Size of foundation openings are found in Table 1 and locations are shown in Figure 1.*

*Location (9A) of inspection is shown in Figure 1. See Photo 4.*

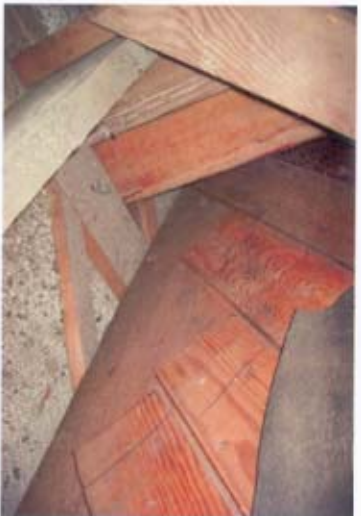
*Location (3A) of inspection shown in Figure 3. Photos 1 & 2 show conditions found.*

Photo 1.  
South end of 3-2x  
ceiling joists.

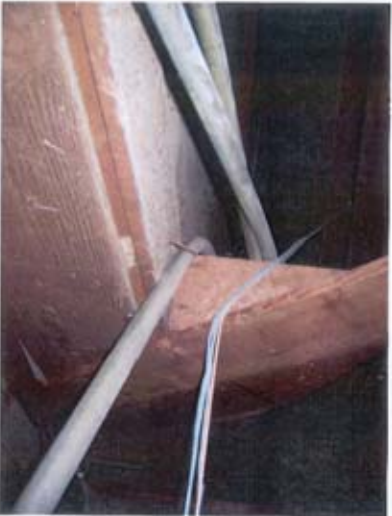
Photo 2.  
Note 1 x 6 bottom plate of  
parapet wall.

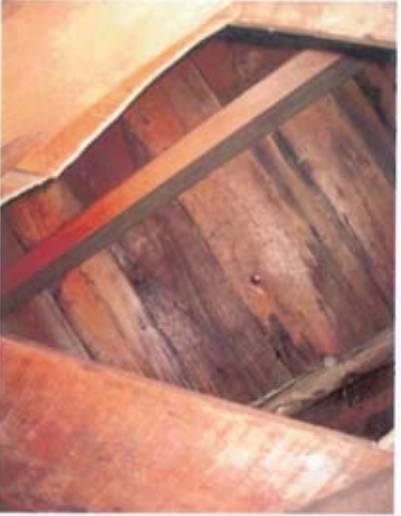
*Roof framing does exist above ceiling framing. 2 x 8 rafters were found. See Photo 3.*

Photo 3.  
Cut-out of ceiling joist  
sheathing exposed roof  
rafters above.

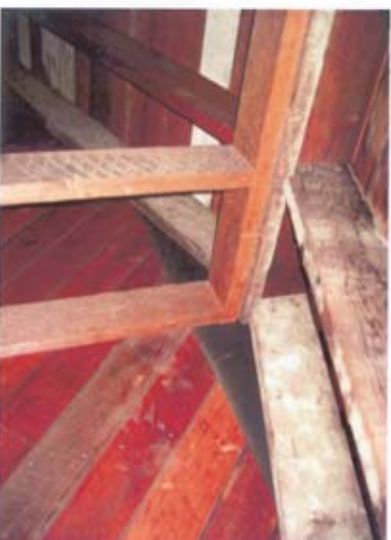
*Roof framing found is shown in SK-1 and SK-2. See Photos 5 through 9.*

Photo 5.  
Framing of ridge to  
auditorium wall, above  
teachers lounge/stage  
side entry door.

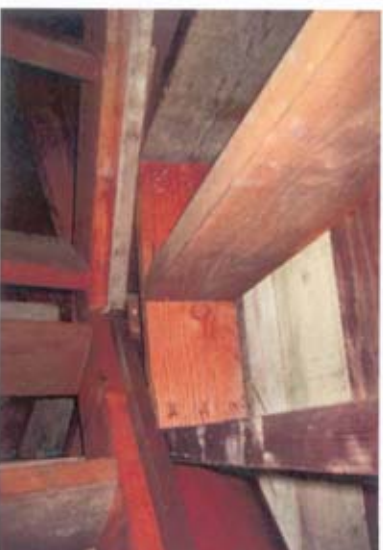
Photo 6.  
Intersecting cripple  
walls of hip framing,  
at ridge.

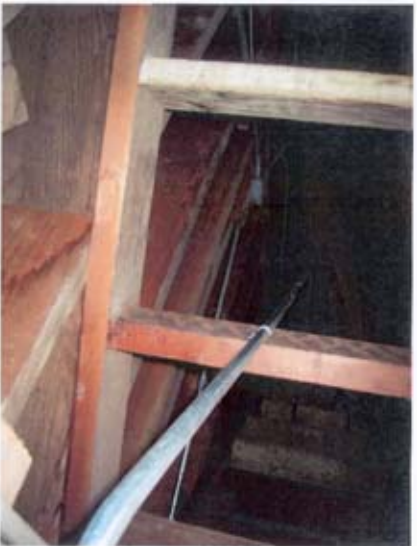
Photo 7.  
Sole plate of "hip"  
cripple wall.  
Note: Blocking of  
ceiling joists below  
wall.

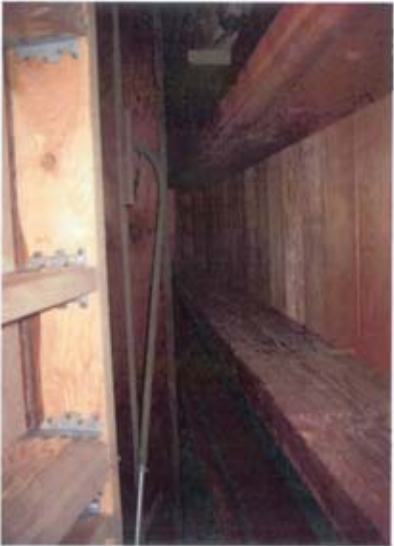
Photo 8.  
Rafters at wall Line N  
Note: Joists held back  
from wall.

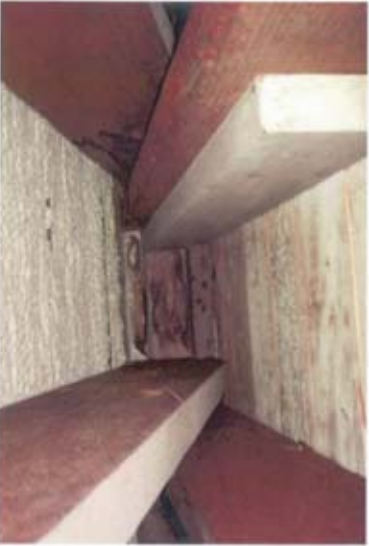
Photo 9.  
Rafters at wall Line 3  
Note: Out-rigger  
nailed to side of rafter.

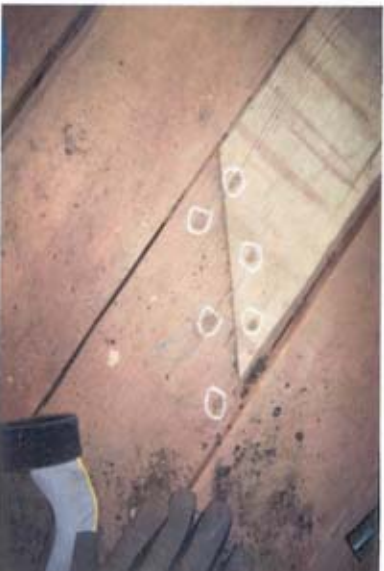
*Locations were as required. See Photo 15.*

Photo 15.  
Typical butt joint  
nailing

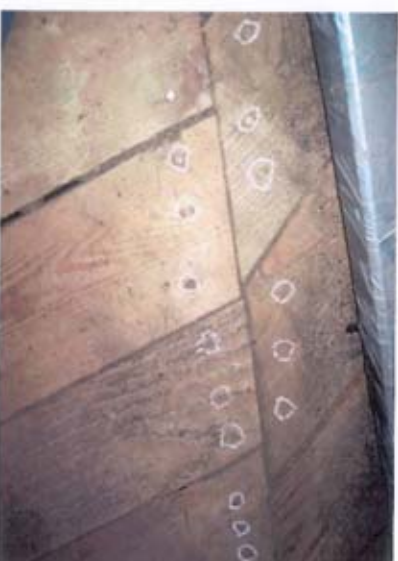
*We found three nails in each sheathing board at butt splices, where the direction of the sheathing changed. Nails were into separate adjacent framing members. See Photo 16.*

Photo 16.  
Nailing at diagonal  
sheathing where the  
direction changes.

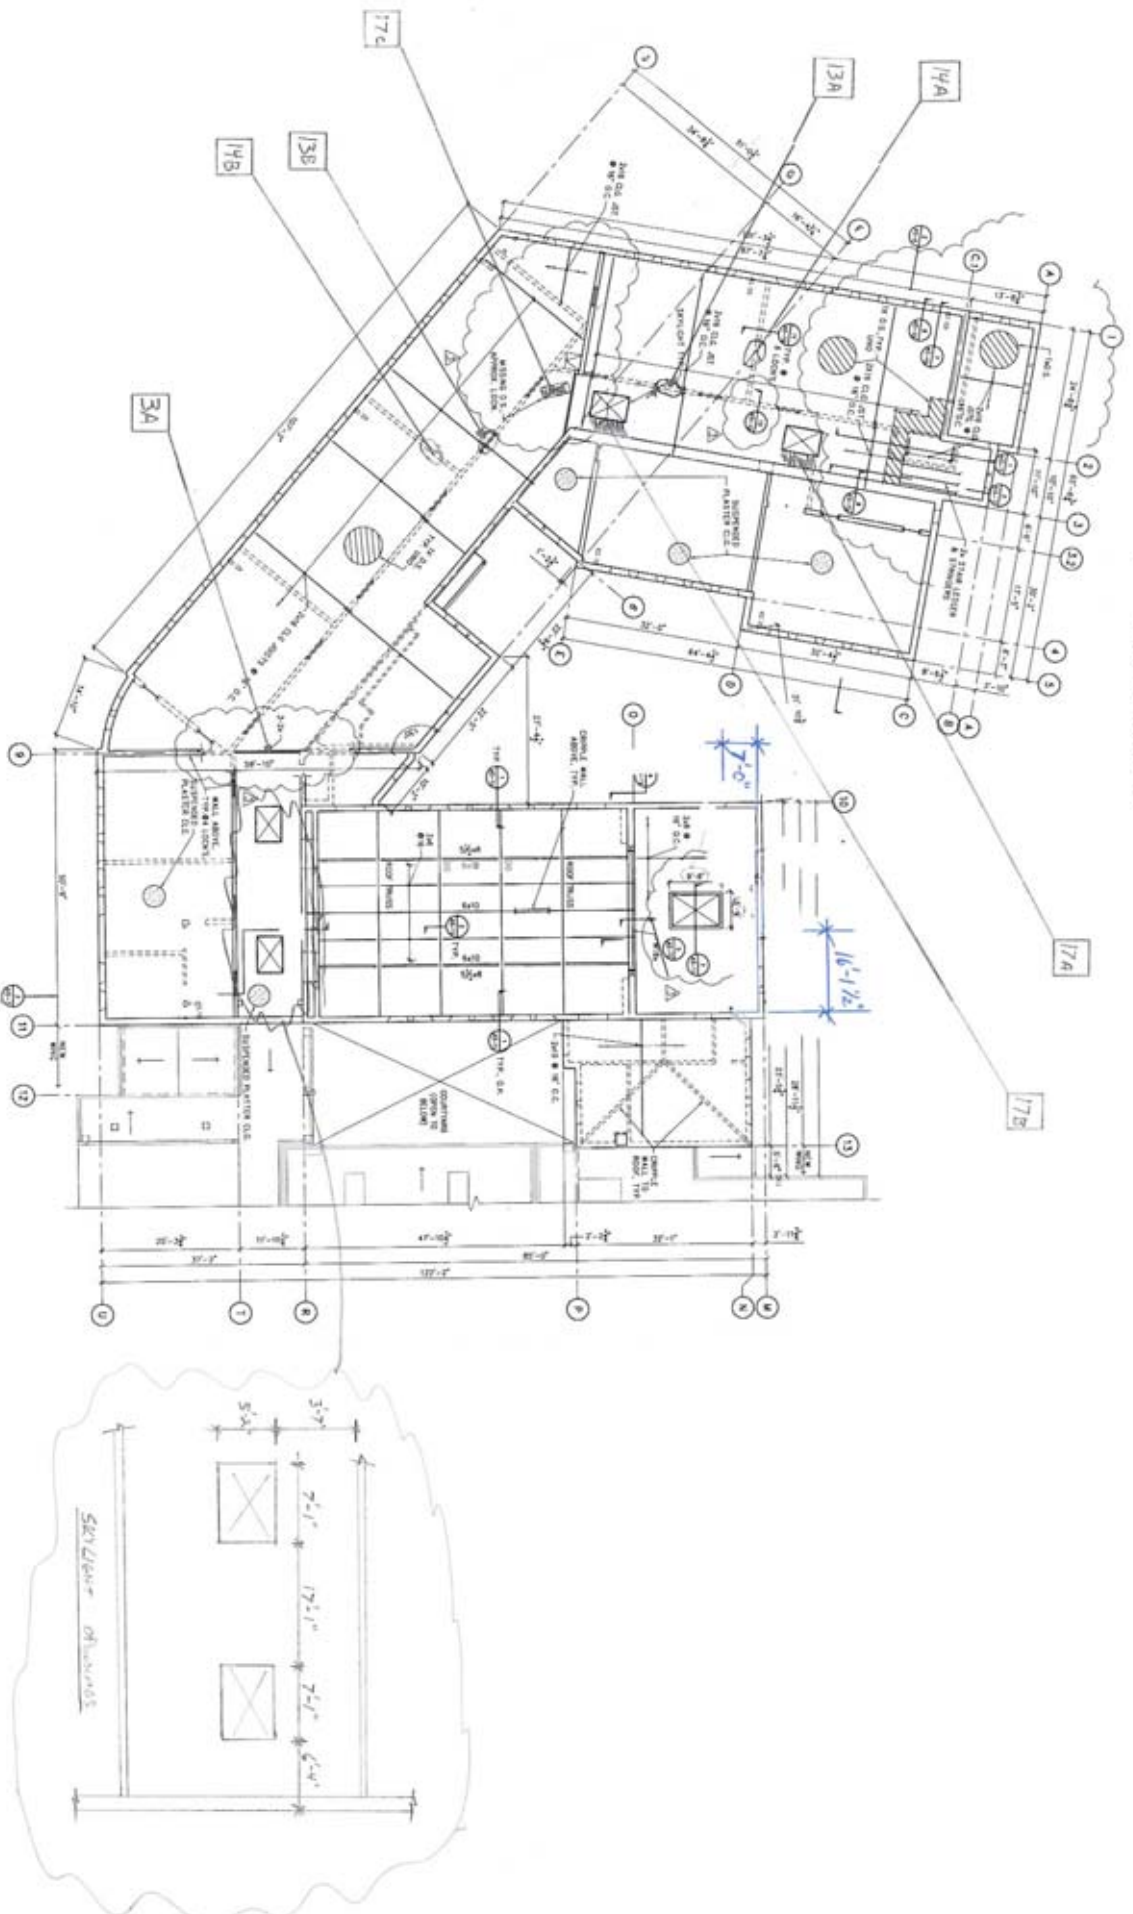
Figure 3. Ceiling plan showing observation locations.

*Locations (13A & 13B) are shown in Figure 3. See Photos 11 & 12.*

*Locations (14A & 14B) are shown in Figure 3. See Photos 13 & 14.*

*Three areas (17A, 17B & 17C) with missing diagonal sheathing were observed. Two (17A & 17B) areas were located between skylights and wall Line 3, both approximately 8' x 3'. The third location (17C) was approximately 2' x 2' and located near the attic access. Locations are shown in Figure 3. See Photo 17.*
