# **PIEDMONT MIDDLE SCHOOL**

**PIEDMONT UNIFIED SCHOOL DISTRICT**

**Seismic Strengthening Program / Measure E Bond Program**

## **COMBINED INVESTIGATION & CONCEPT DESIGN FINAL REPORT**

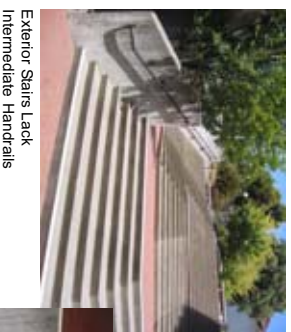
Exterior Stairs Lack Intermediate Handrails

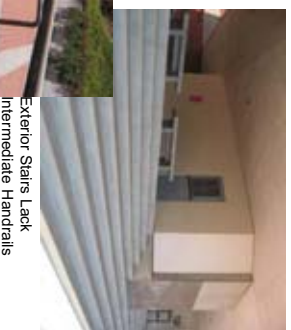
Exterior Stairs Lack Intermediate Handrails

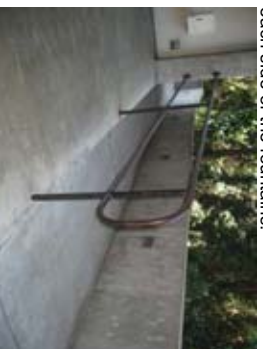
Building B - Ramp not compliant

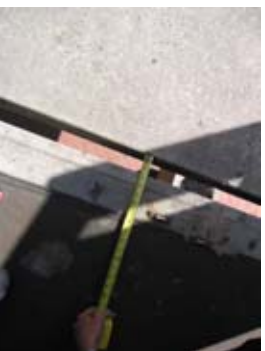
Building B - Seismic Joint gap not filled

- 33 FILL SEISMIC GAP FOR ADA COMPLIANCE.
- 34 PROVIDE (N) SEAT WALL BARRIER AT EXTERIOR STAIRS.
- 35 MODIFY OR REPLACE ONE LOCKER TO BE ACCESSIBLE.
- 36 ADD NEW FIRE ALARM AND FIRE SPRINKLERS THROUGHOUT.

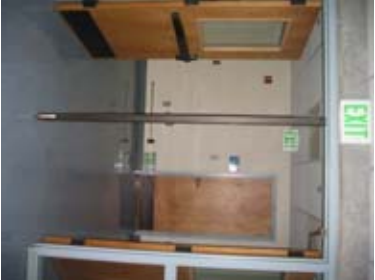
Building D Upper Floor Exit from Corridor

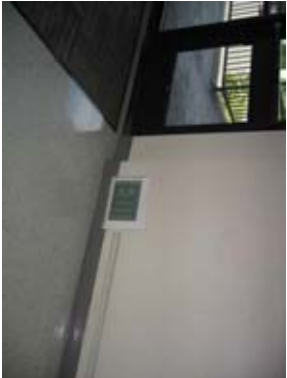
Building E Upper Floor Exit

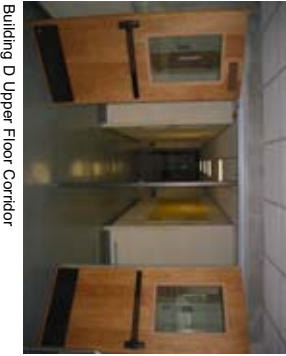
Building D Upper Floor Corridor

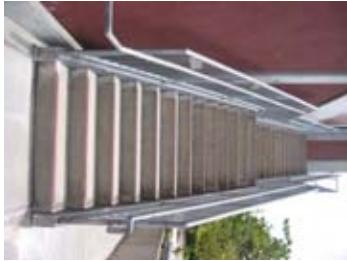
Building E - Exit stair

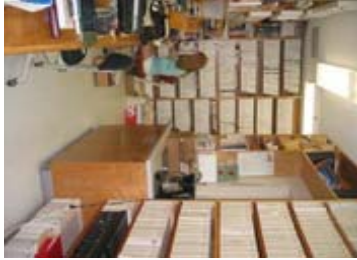
Building E - Music Office / Library

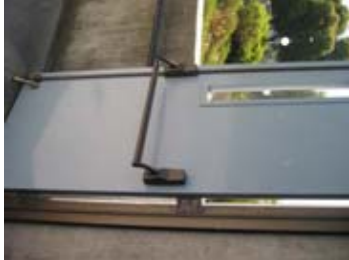
Building B - Panic Hardware

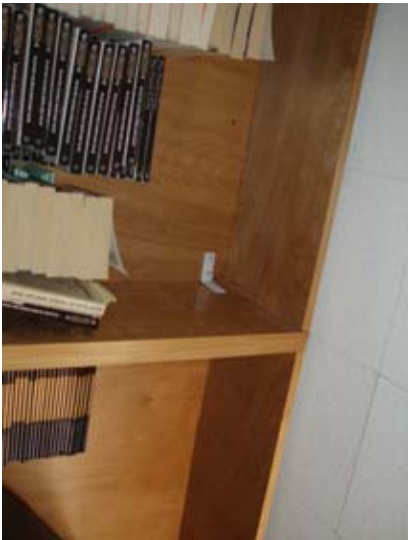
There are many bookcases and storage cabinets located throughout the school. Most of these are secured to walls (Figure 5) and are unlikely to overturn, although contents may fall out. Some cabinets and bookcases are free-standing and unanchored. Those over 4 feet tall with height to depth ratios of 3.0 or greater are considered a hazard to overturn (Refs. 1 and 2).

Figure 5 – Angle bracket used to secure bookshelf to wall. This is one of the types of restraints used to keep bookcases from falling over.

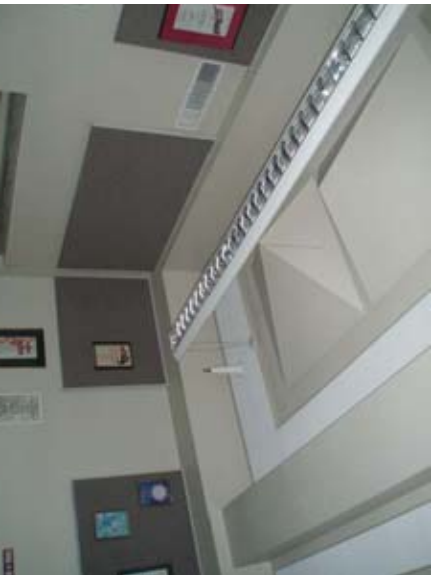
Fluorescent fixtures that are ceiling-mounted and connected to concrete slabs or wall board ceilings are considered low risk. Chain and cable-hung (Figure 8) are also considered low risk.

Figure 8 – This fluorescent light fixture in the Gym/Music building is hung on a small cables (cable-hung) and is not considered a falling hazard.

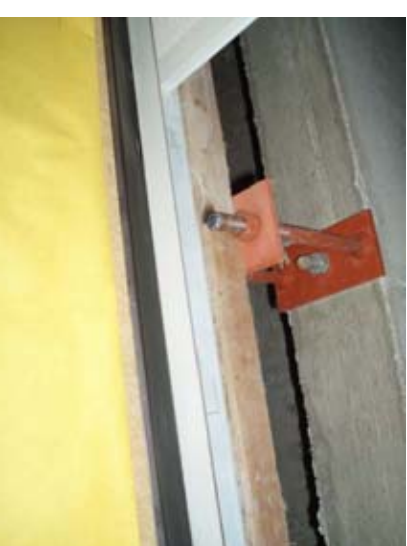
In Building B, several classrooms at the Upper Level (Rooms 302-308) and Lower Level (Rooms 102-108) are separated by moveable room dividers (i.e., moveable partitions). These are secured at the tops by several steel brackets (see Figure 9 for example) that are bolted to concrete beams. The room dividers do not appear to be seismic hazards.

Figure 9 – Typical bracket used to secure the moveable partitions to the structure in the Building B. The tops of each partition are restrained by several of these.
